IN-SITU FIELD MONITORING OF A UHPC AND HPC BRIDGE SUPERSTRUCTURE UNDER DIAGNOSTIC LOAD TESTING USING DIGITAL IMAGE CORRELATION

A thesis submitted in partial fulfillment
of the requirements for the degree of
Master of Science in Civil Engineering
Department of Civil Engineering

The University of Texas at Tyler
May 2019

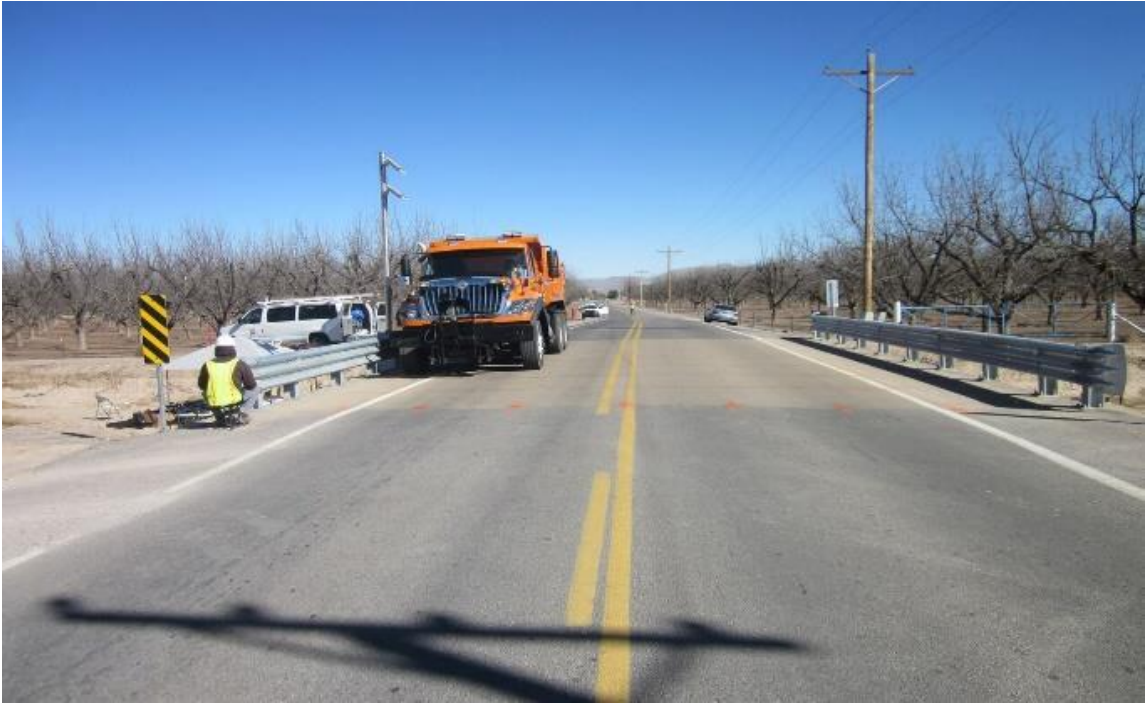
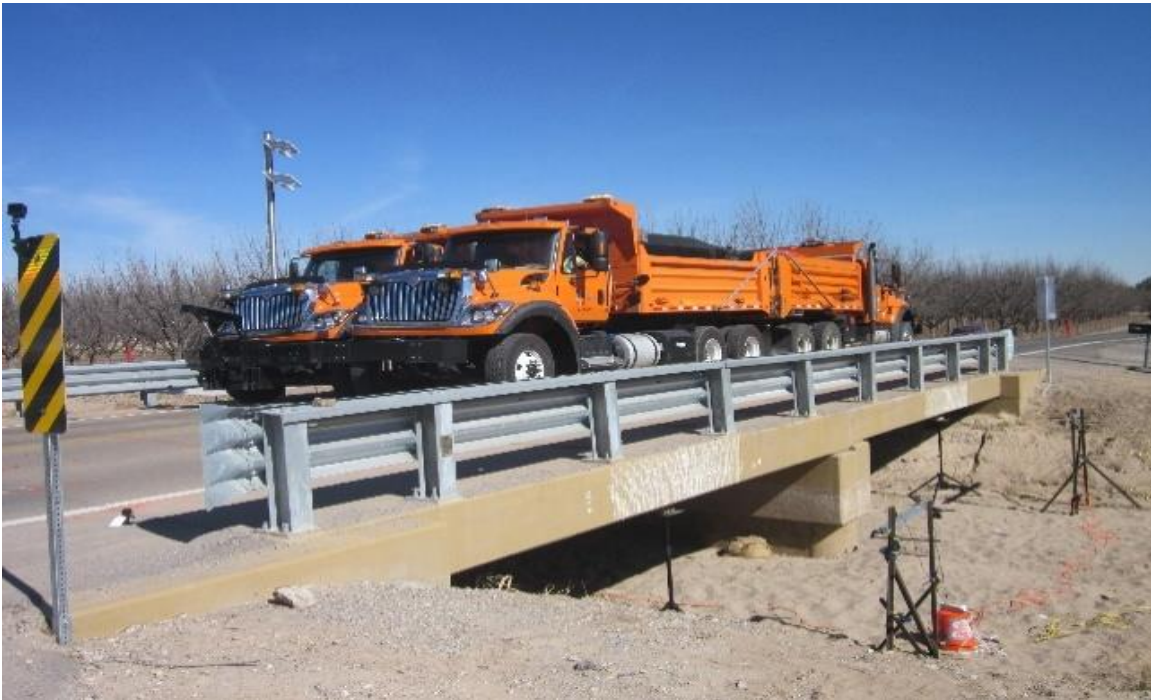
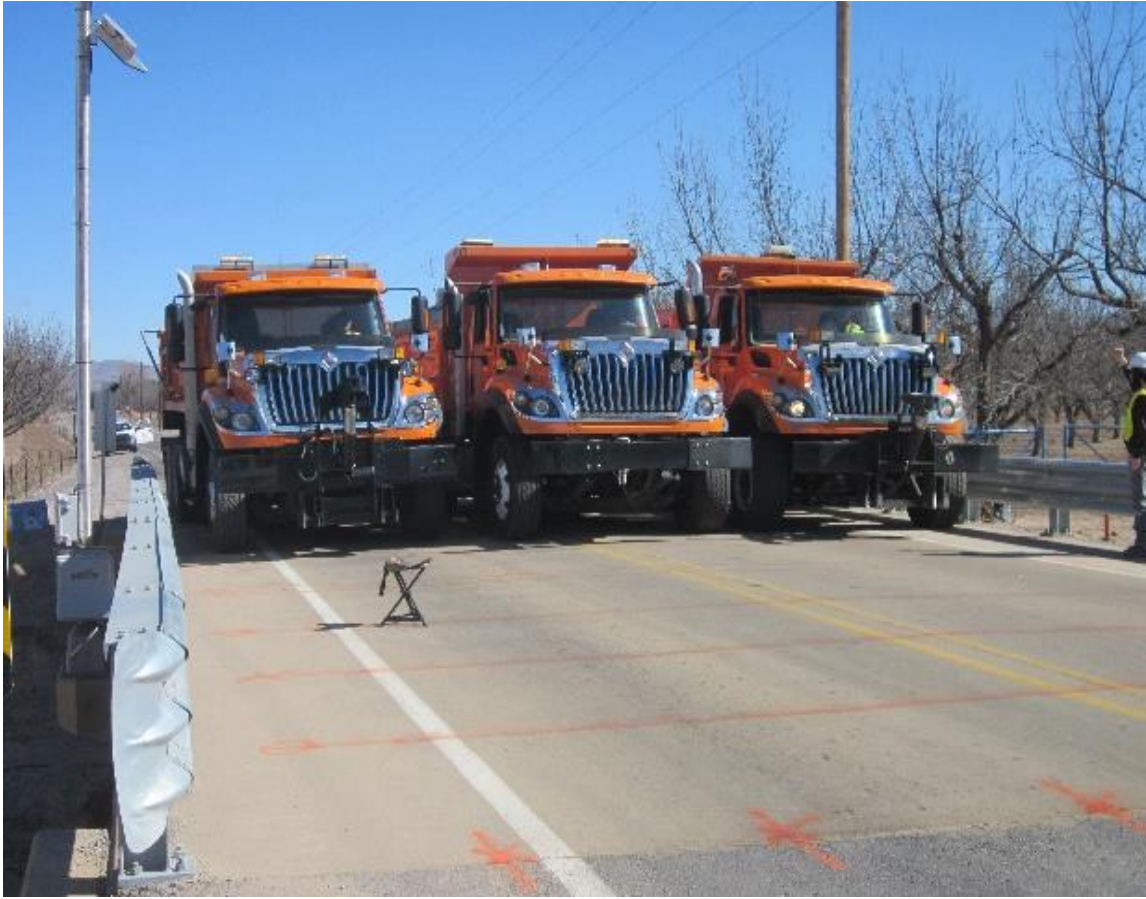
Figure 4. Transverse load paths for a test vehicle (NOTE: 1 ft. = 0.3 m)

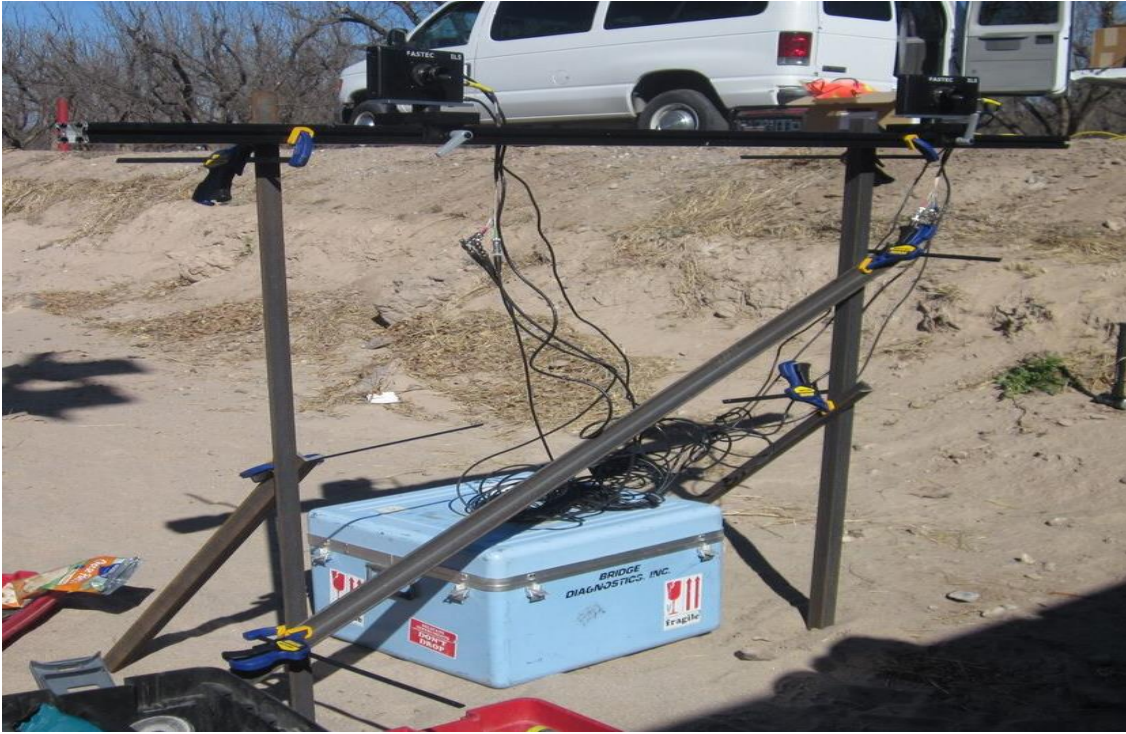
Figure 6. FASTEC IL5 System for monitoring exterior girder of UHPC span

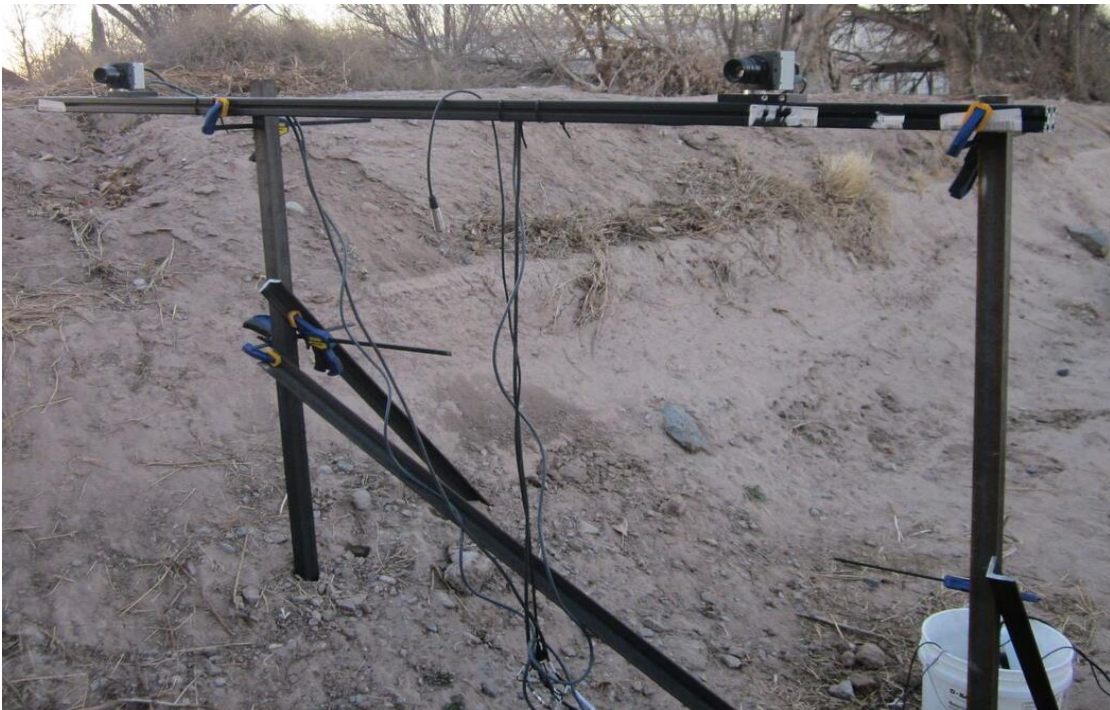
Figure 7. FASTEC HiSpec1 System for monitoring exterior girder of HPC span

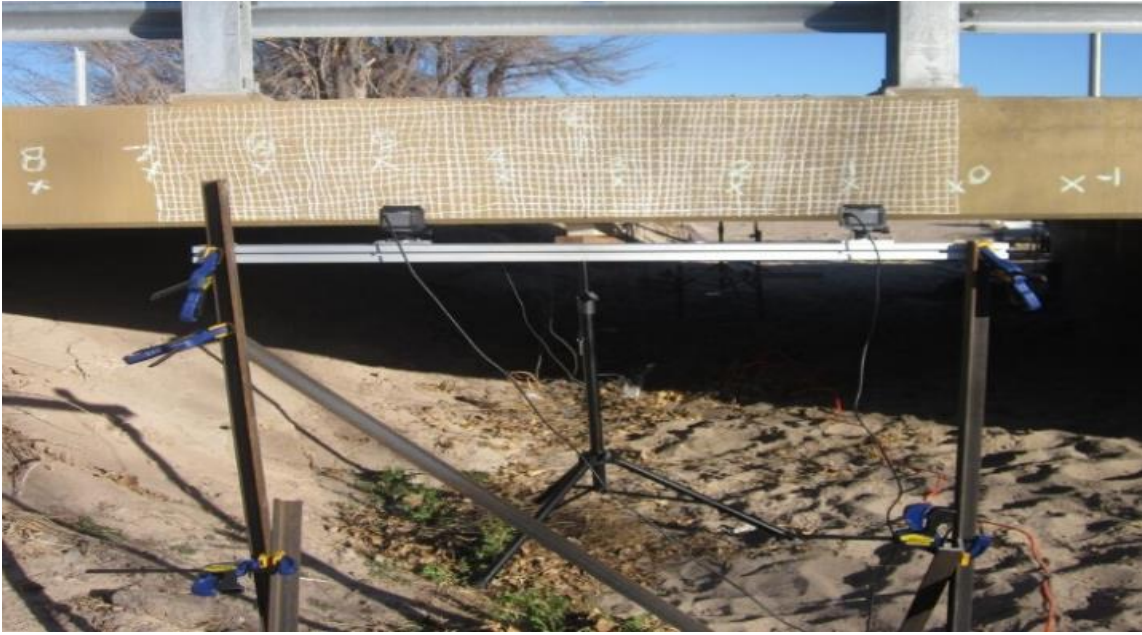
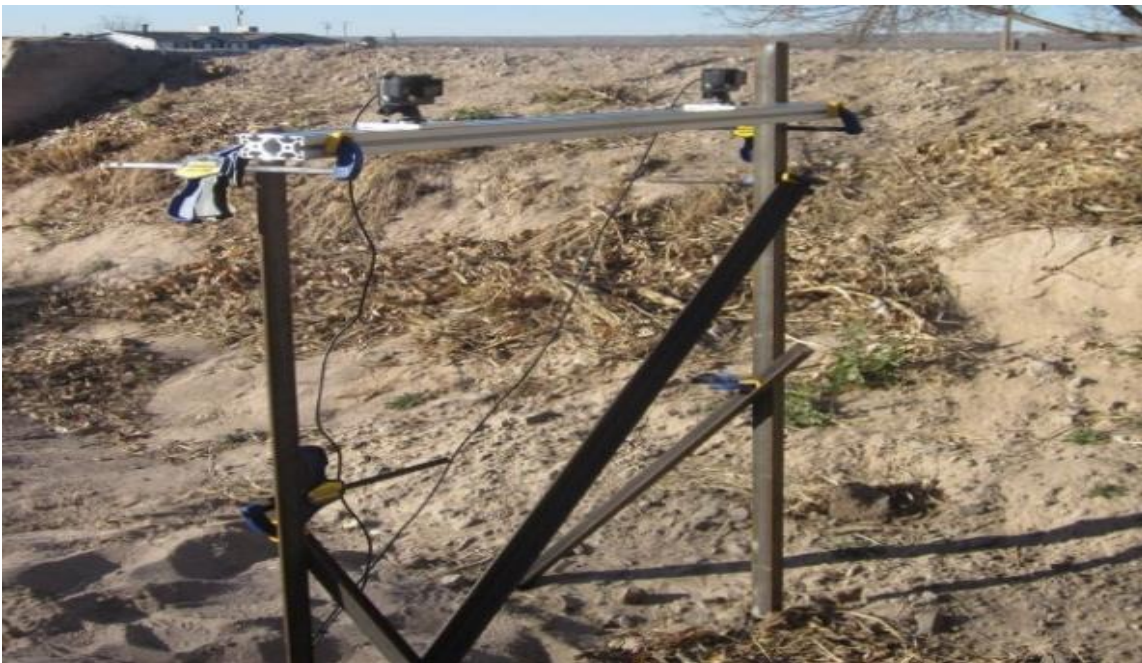
Figure 8. GoPro Hero + System for monitoring exterior girder of HPC span (a) view from behind cameras, (b) view from in front of cameras

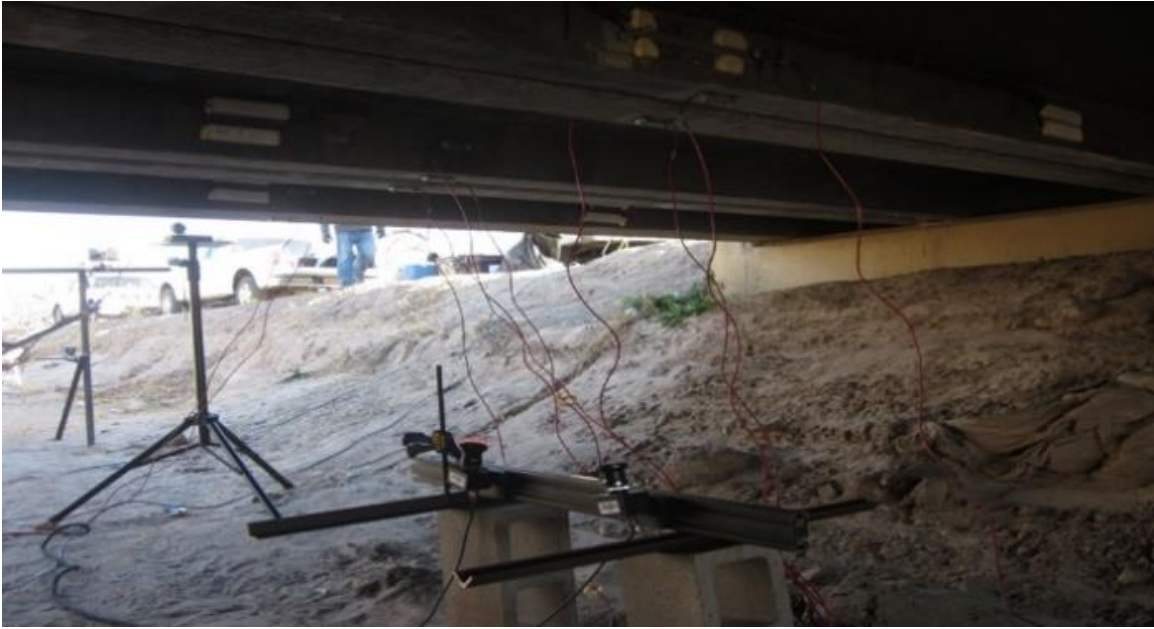
Figure 10. 2M System for monitoring an interior girder of UHPC span

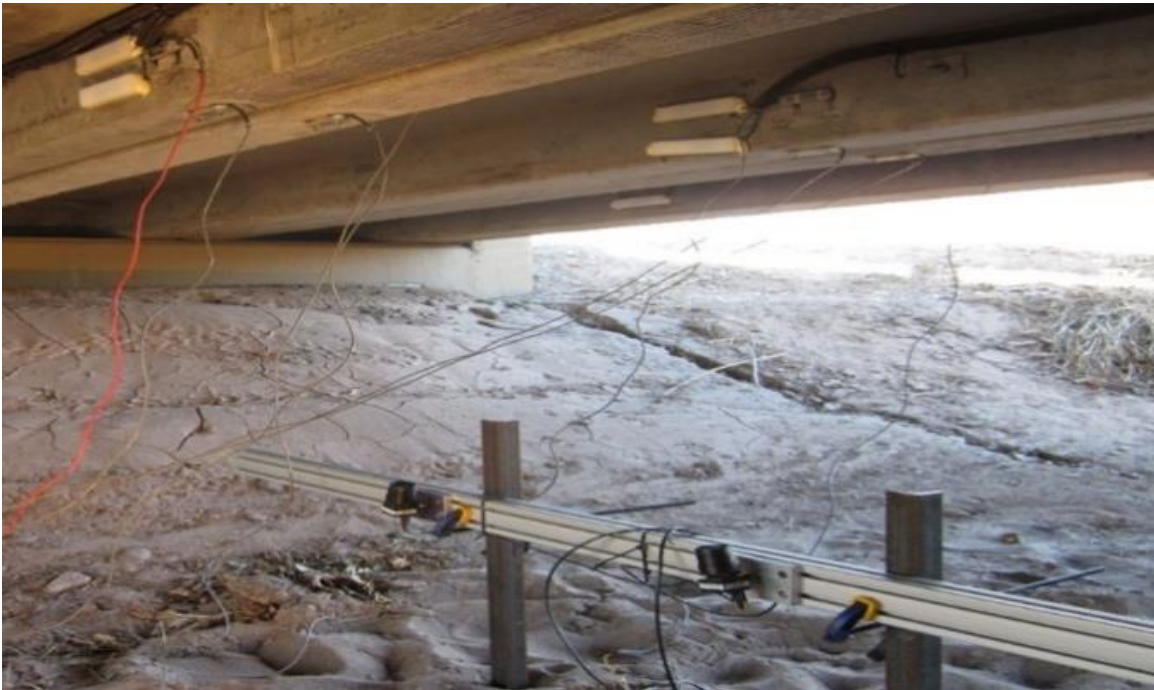
Figure 11. 2M System for monitoring an interior girder of UHPC span

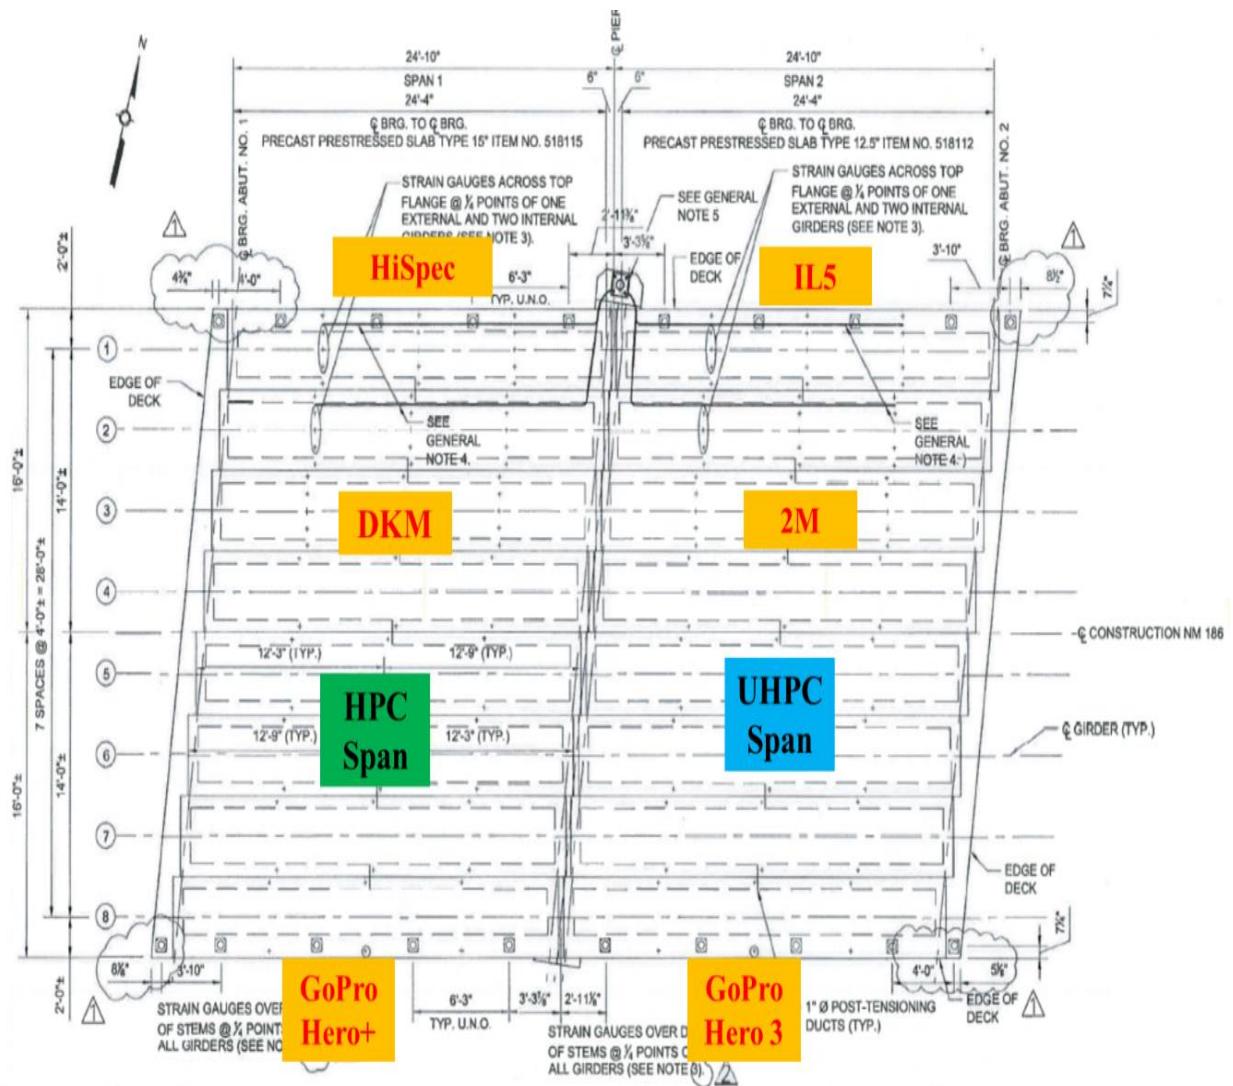
Figure 14. Location of each DIC camera system for Test setup 1

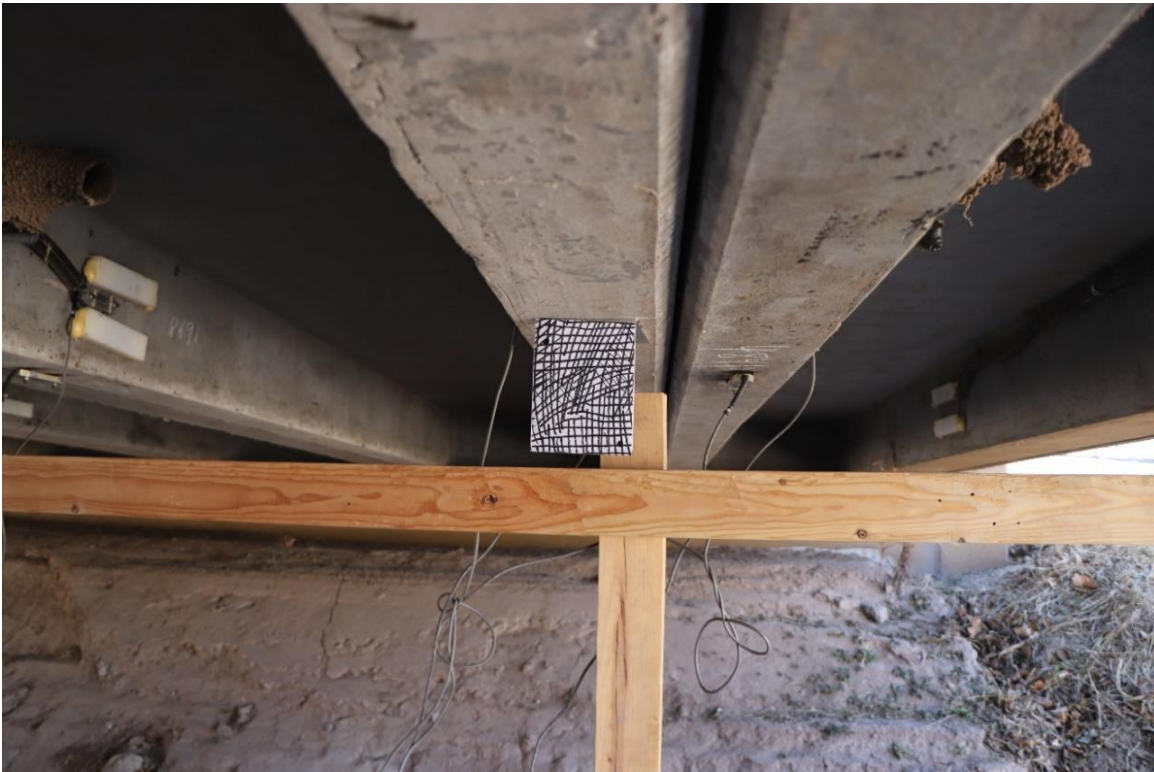
Figure 17. Internal girders with attached targets for displacement measurement

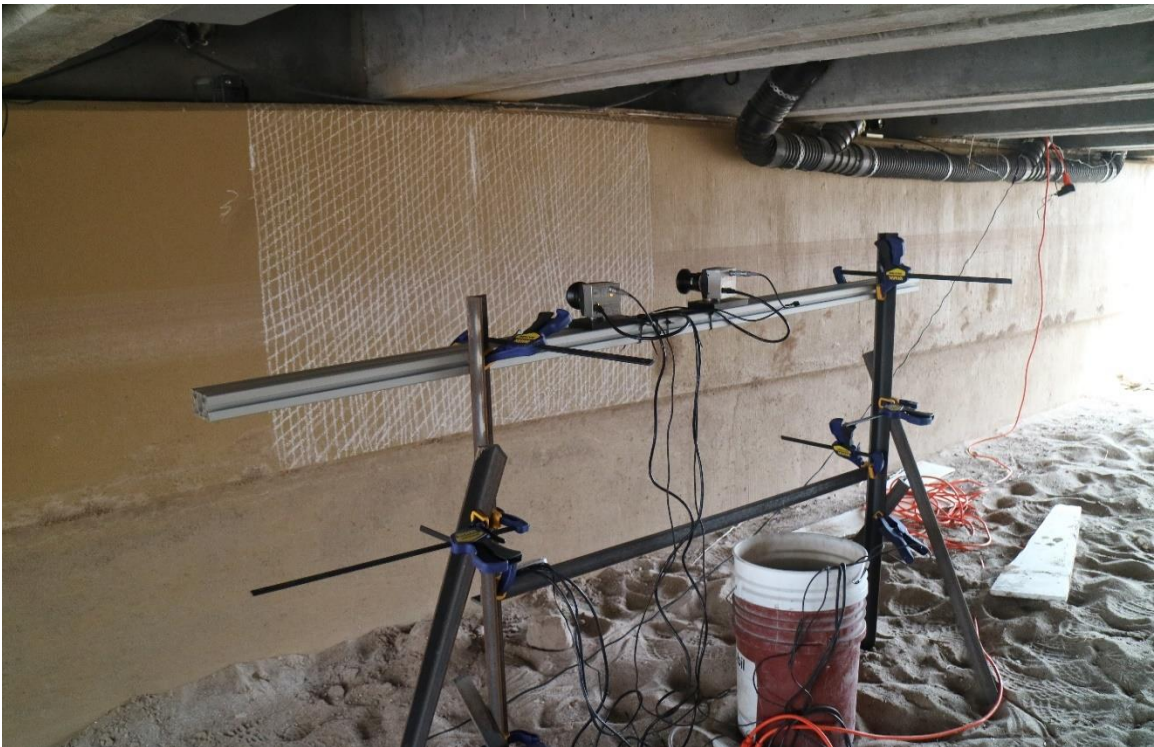
Figure 21. Hi-spec camera system for measurement of out-of-plane displacement of the bridge pier

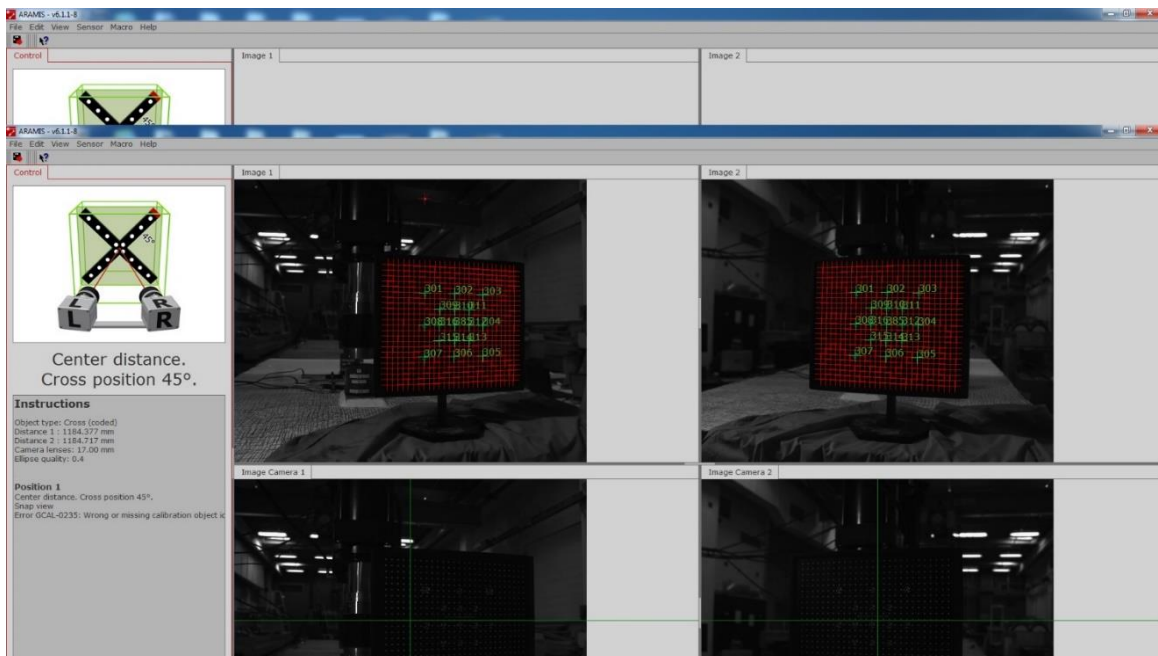
Figure 23. Image of Calibration screen display with calibration panel

board can be changed. The images during the process are taken. The image is shown on the window on the right and left sides immediately. The calibration board shows a green light if the points on the board are identified. The image should be re-taken, or the board should be placed again if the green points do not flash. Figure 23 shows an example of a calibration being done using a calibration panel.

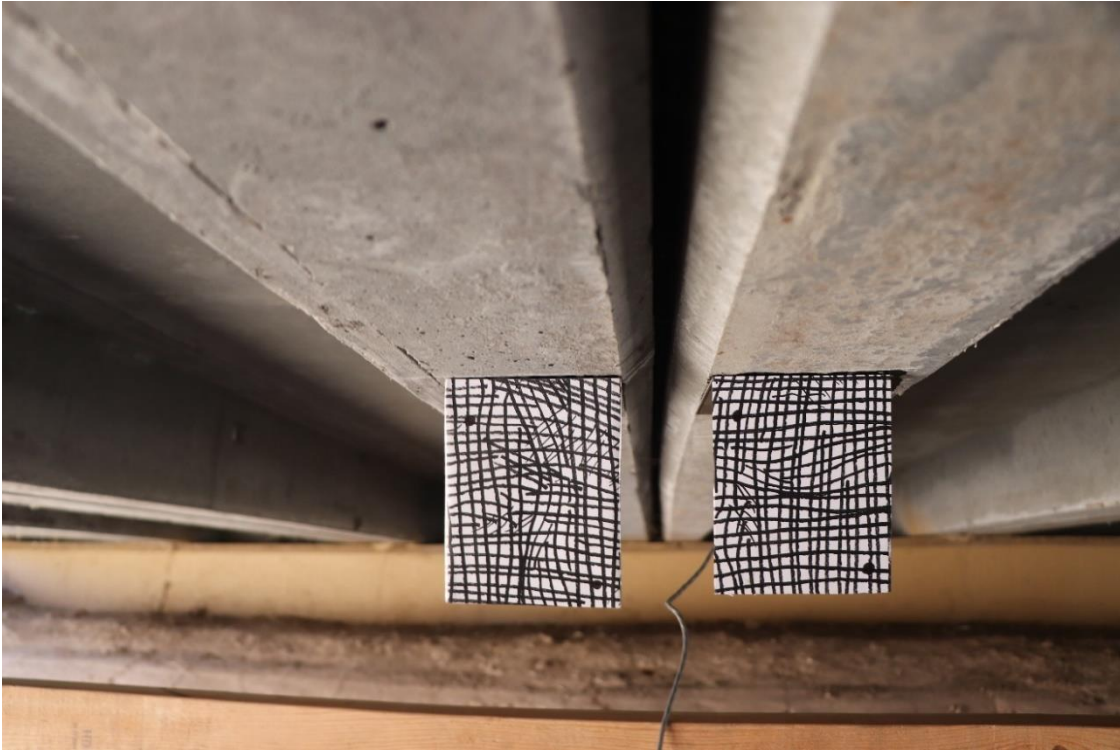
Figure 28. Pattern with high contrast attached to the internal girder

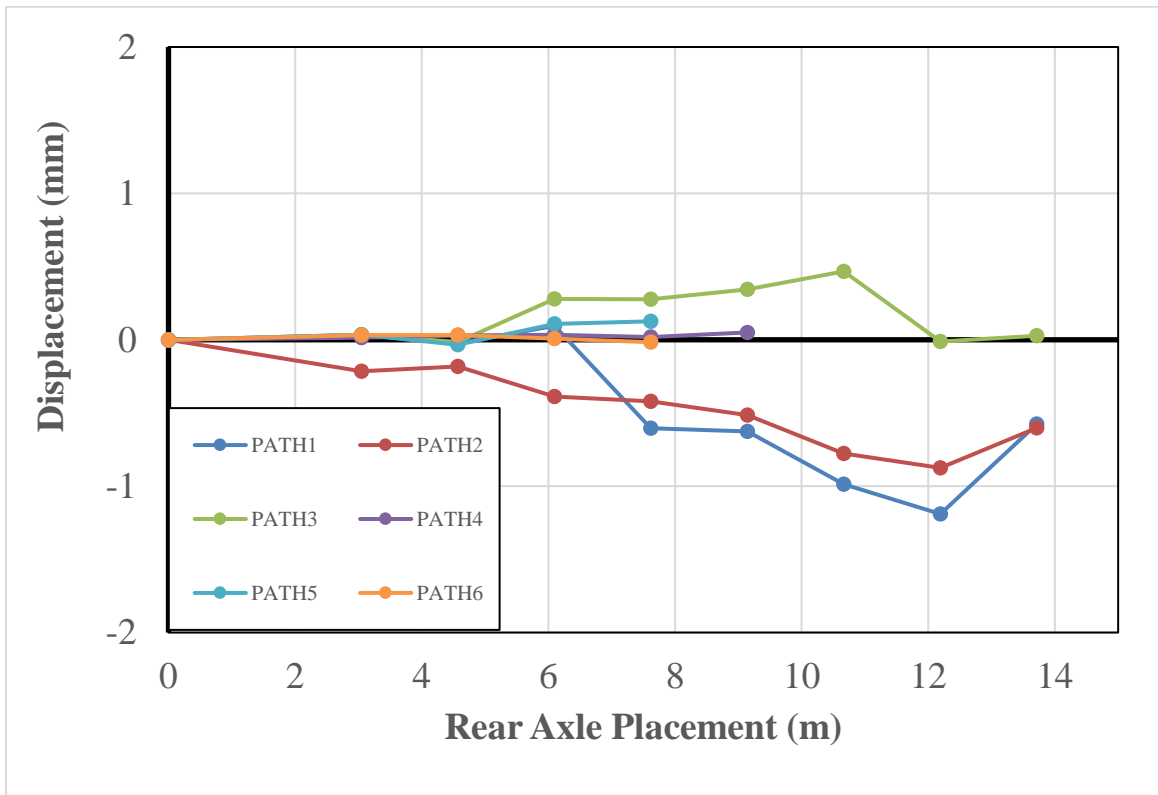
Figure 31. Displacement vs rear axle placement for an exterior HPC beams for single truck loading measured by the HiSpec1 system

Truck on the bridge for paths 1-6 shown in Figure 2 are presented in Figure 31 with the corresponding numerical values in Table 4. It is noted that path 1 is closest to the HiSpec1 system while path 6 is farthest away. As expected, the greatest response is when the truck is moving along path 1 and the rear axle is directly over the location of the measured field. The peak vertical displacement for this test run is 1.2 mm (0.05 in.). It is interesting to note that when the truck is running along path 3 there appears to be some twisting in the bridge with the exterior girder moving slightly upward 0.47 mm (0.02 in.). This upward motion is present but faint for paths 5 and 6. The data from path 2 seems to suggest some continuity between the two spans as there is a slight downward movement on the HPC side when the truck is on the UHPC span.

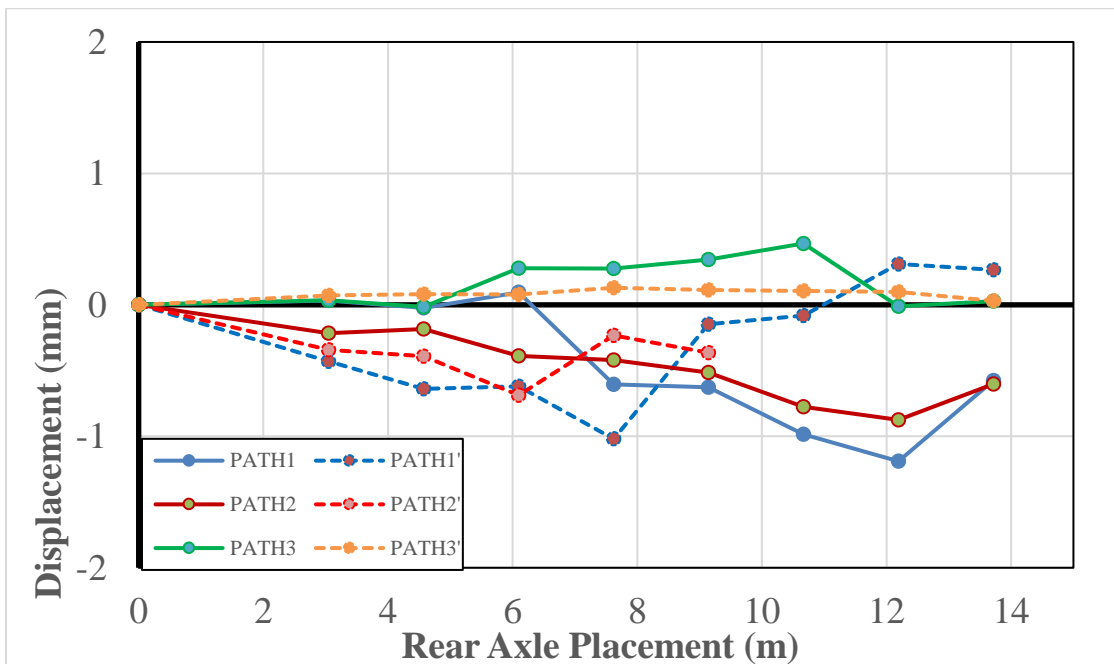
Figure 39. Comparison of displacement vs rear axle placement for the exterior beams from IL5 (dashed lines) and HiSpec1 (solid lines) under single truck loading

A comparison of vertical displacement was completed at the mid-span of the exterior girders monitored by the IL5 and HiSpec1 systems for a single vehicle on paths 1-3. The results for this are shown in Figure 39 with the corresponding numerical values in Table 15. The dashed and solid lines correspond to the IL5 and HiSpec1 systems respectively. For both beams the maximum downward vertical displacements occur when the truck is along path 1. This maximum value is 1.02 mm (0.04 in.) and 1.19 mm (0.047 in.) for the UHPC and HPC spans respectively. Path 3 produces an upward movement of the exterior girder for both spans with the larger result on the HPC span. While comparing the values for displacement for UHPC and HPC beams at similar stages and under similar loading stages, the displacement value of HPC beam are comparatively higher than the UHPC beam.

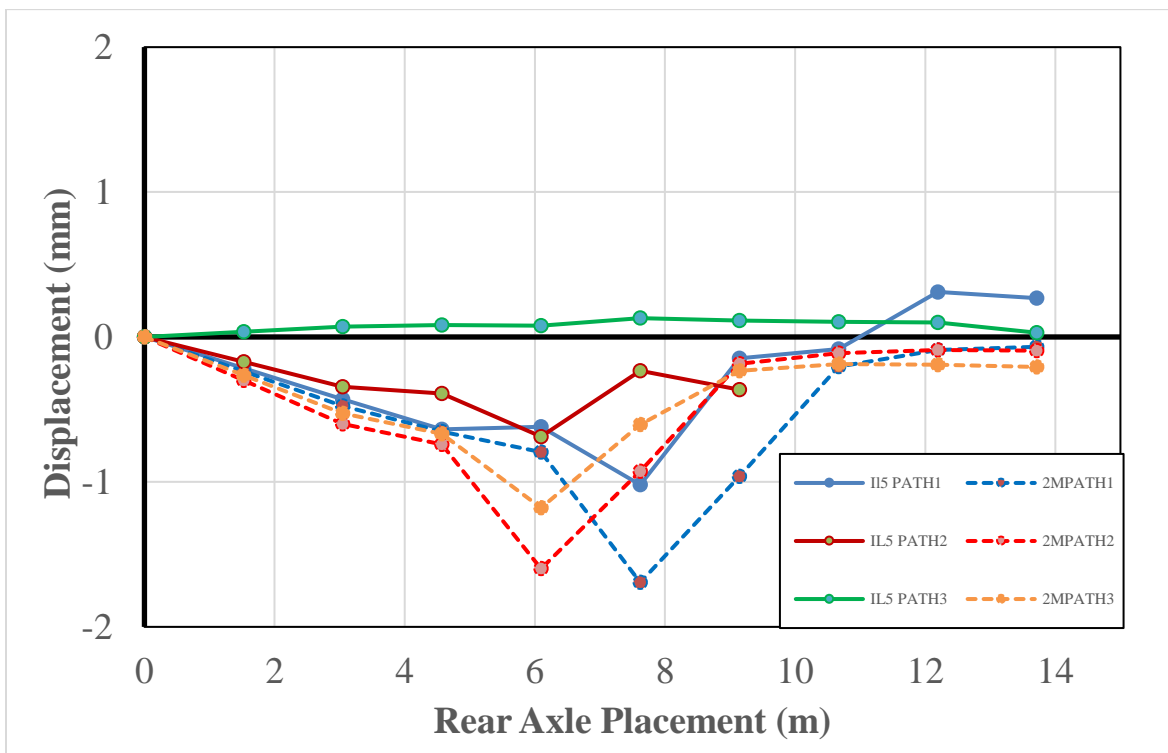
Figure 41. Comparison of vertical displacement vs rear axle placement for beams from IL5 (solid lines) and 2M (dashed lines) systems under single truck loading

The IL5 and 2M systems were compared for testing in paths 1-3 for a single truck loading and shown in Figure 41 and Table 12. The data indicates higher vertical displacement measured by the 2M system towards the center of the bridge compared to that measured by the IL5 on the exterior. It was expected that the exterior girder should have higher displacements than an interior girder because the loading is near the exterior. Path 2 on the other hand is more directly over the location of the 2M system so that should have higher displacement. A possible reason for the lower displacements on the exterior girder is the result from a stiffer cross-section compared to an interior beam. More investigation into this finding needs to be completed before any conclusions can be drawn.

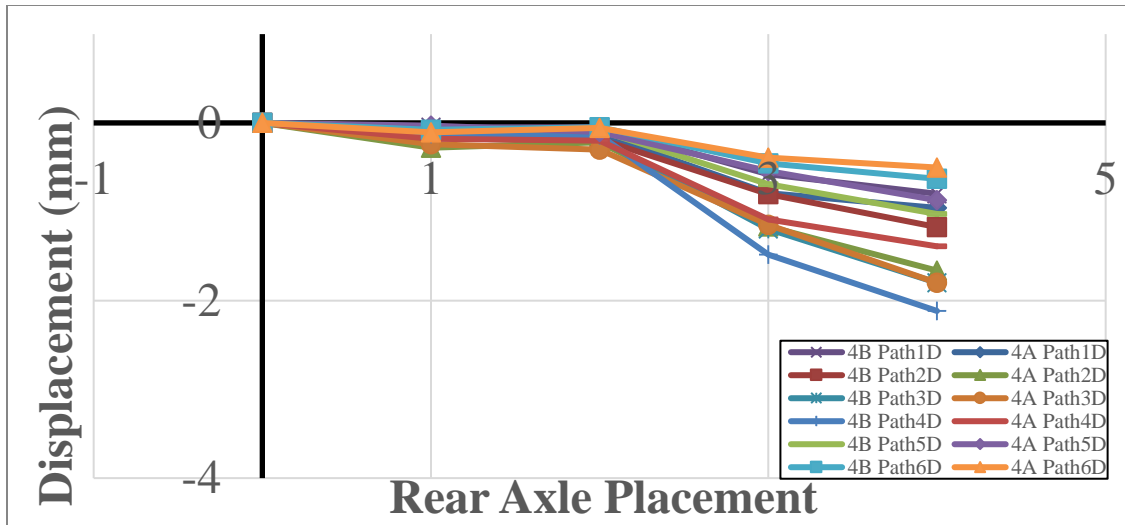
Figure 54. Displacement data for back-to-back loading from path 1 to 6

on path 6D. The numeric displacement value is summarized in Figures 54 and Table 31 and 32.
