## Experimental Investigation of Adobe Structures with Digital Image Correlation

EXPERIMENTAL INVESTIGATION OF ADOBE STRUCTURES WITH  
DIGITAL IMAGE CORRELATION

A thesis submitted in partial fulfillment  
of the requirements for the degree of  
Master of Science in Civil Engineering  
Department of Civil Engineering

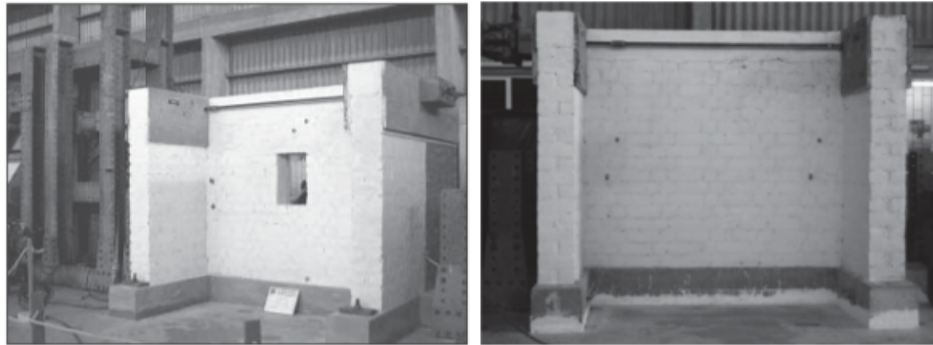
(a) with window opening  
(Blondet, 1978)

(b) without window opening  
(Blondet, 1978)

*Figure 2.3. Wall specimen during testing.*

(Blondet, 1978) , performed experiment on three I-shaped adobe walls which were similar in size. One wall had a window opening and other two did not as shown in figure2.3 (a) and (b) respectively. All of the three walls were not reinforced.

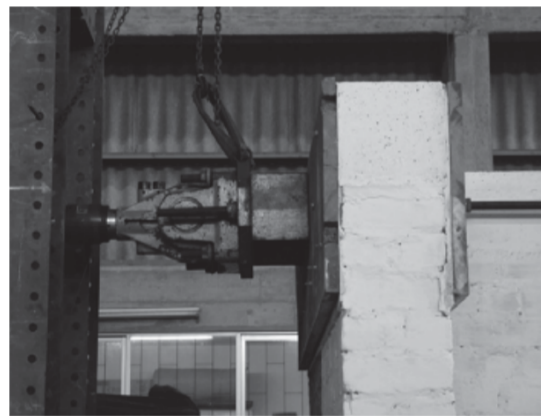
*Figure 2.4. Application of load in the wall*  
(Blondet, 1978)

The wall was loaded horizontally from the top corner with the aid of hydraulic actuator as shown in Figure 2.4. Horizontal cracks appear at the bottom of the wall while diagonal cracks appear from both direction of the wall. The walls without windows were stiff initially than the walls with windows. From the cyclic test, the modulus of elasticity for full scale adobe walls was suggested to be 29,000 psi to 32,000 psi.

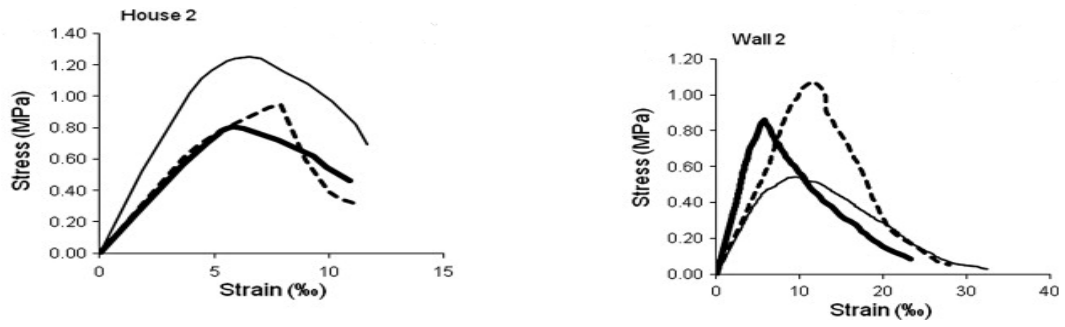
Figure 2.5. Stress strain curve for House 2 and Wall 2.  
(Silveria 2012)

adobe specimens. The specimen was loaded until failure, with the measurements as shown in Figure 2.5.

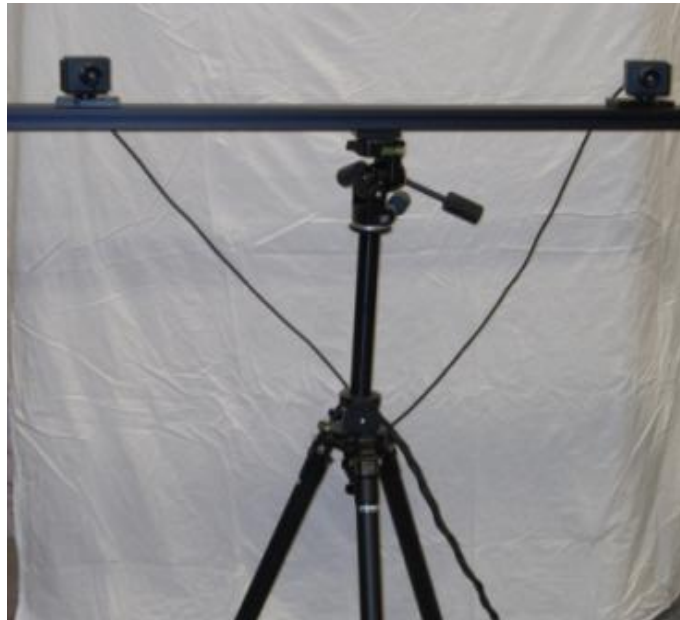
*Figure 2.3. schematic representation of DIC*

in various engineering applications. Most commonly it measures displacements that can then be converted into strains. DIC is also useful in verification of finite element models, and analysis of structures. It works on the combination of image correlation technique with triangulation principle. Figure 2 shows a schematic representation of DIC system.

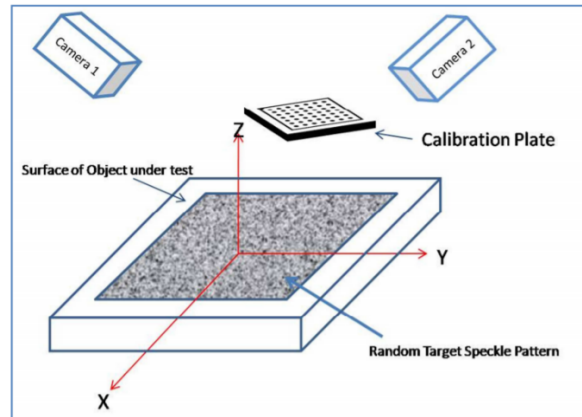
*Fig 2.5. DIC calibration procedure*

The quality of measurement relies on the calibration process. For the calibration process, calibration panels are photographed from different distances and orientation from the test object as per the instructions shown in the computer system. Figure 2.5 shows calibration process which includes calibration panel, specimen and the cameras. Required number of adjustments are made to establish precise relation between the two digital cameras.

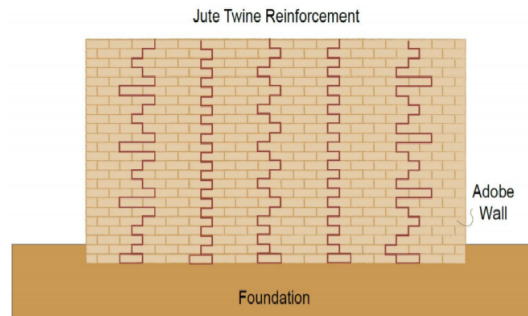
*Figure 4.4. Reinforcement Pattern 1. (Davila 2019)*

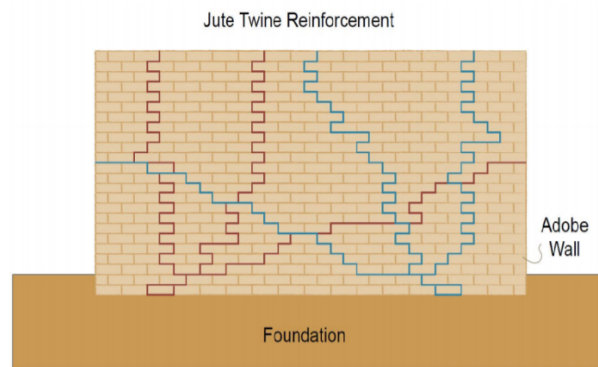
*Figure 4.5. Reinforcement Pattern 2. (Davila, 2019)*

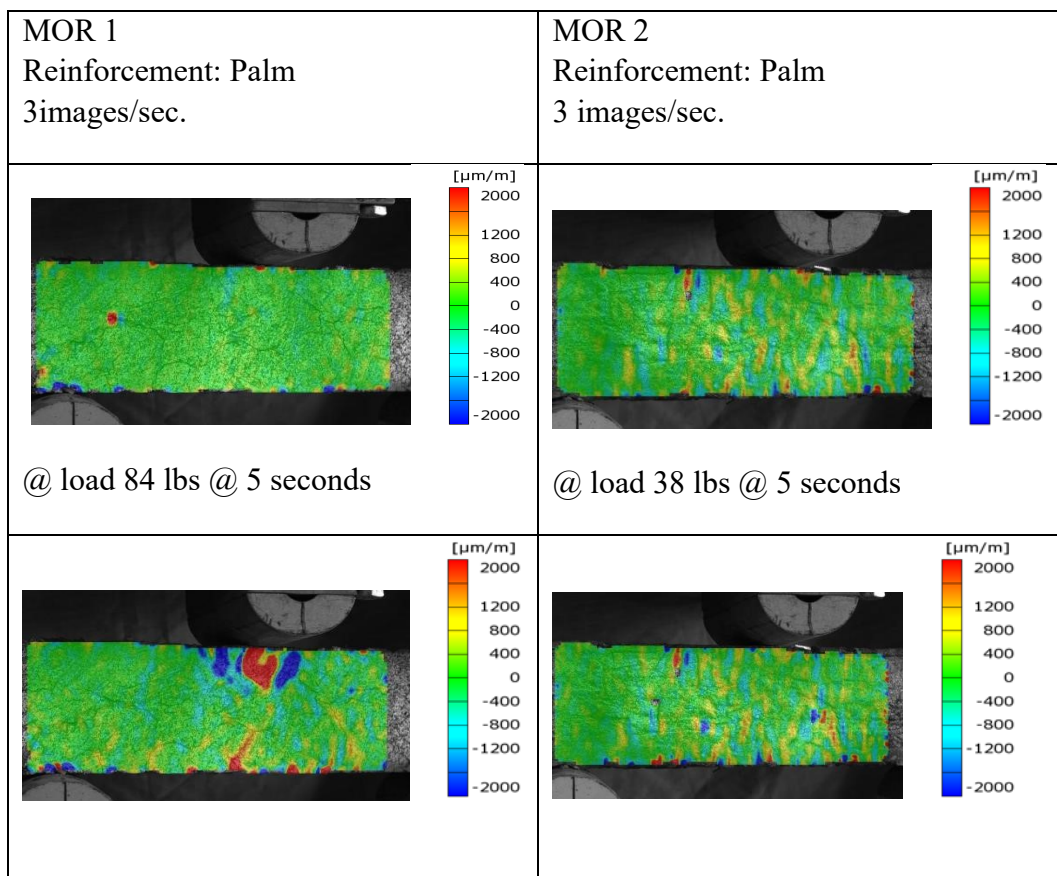
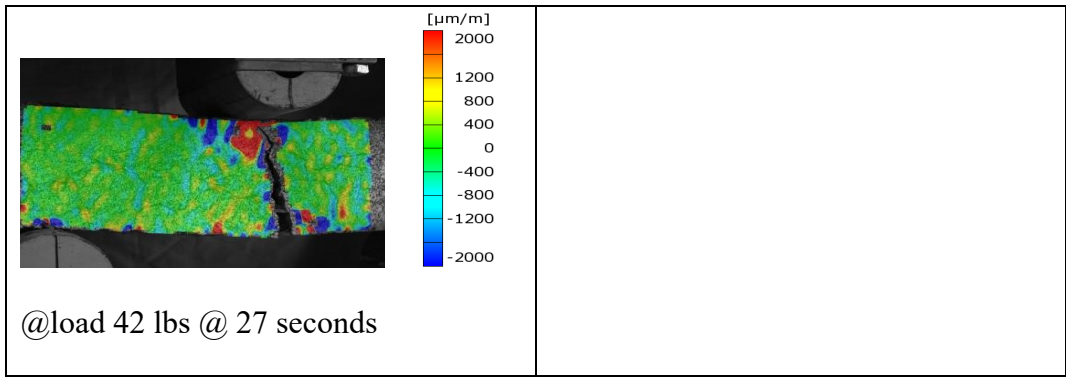
*Figure 5.1. Longitudinal strains for specimen 1 and 2 at different loads.*

Testing of MOR specimens 1, 2, 3, 4, 5, 5B, 6, and 7 were tested under 3-point loading. The loading was applied at a rate of 2.54 mm/min (0.1 inch/minute). One camera system was used to monitor the surface strains and deformations on the front longitudinal faces of the beams. Images of the surface strains along the longitudinal axis of the beam (x-direction) are shown in Figures 5.1 – 5.4, ARAMIS software was used for the analysis of crack development in the beam sample.

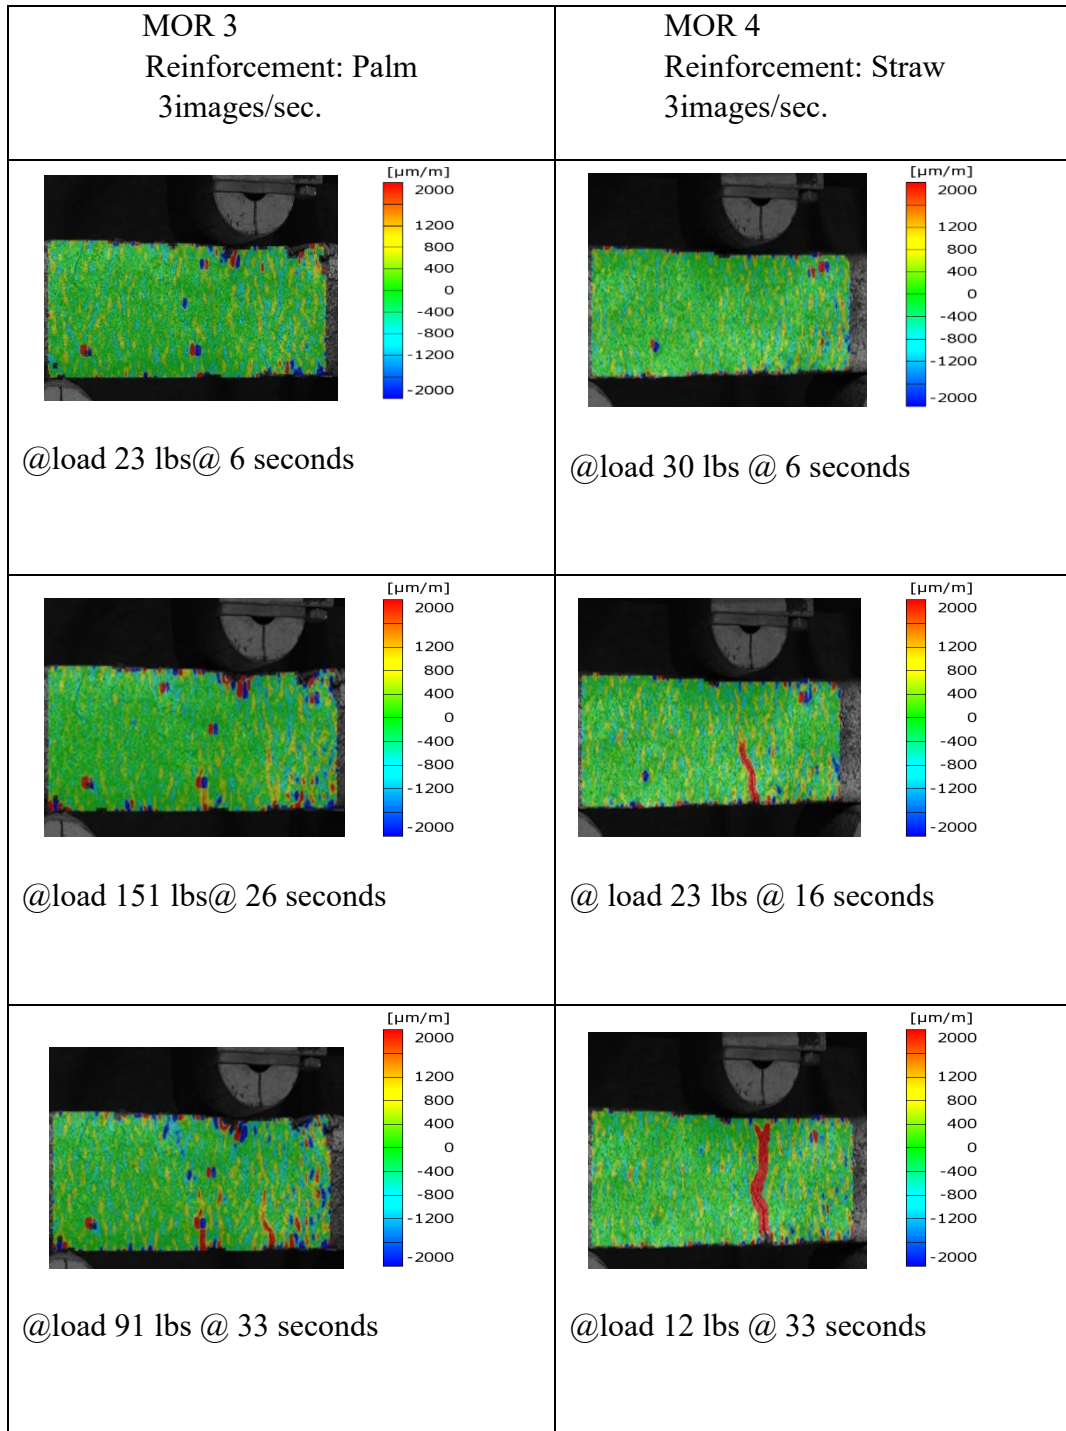
Figure 5.2. Longitudinal surface strains for MOR specimens 3 and 4

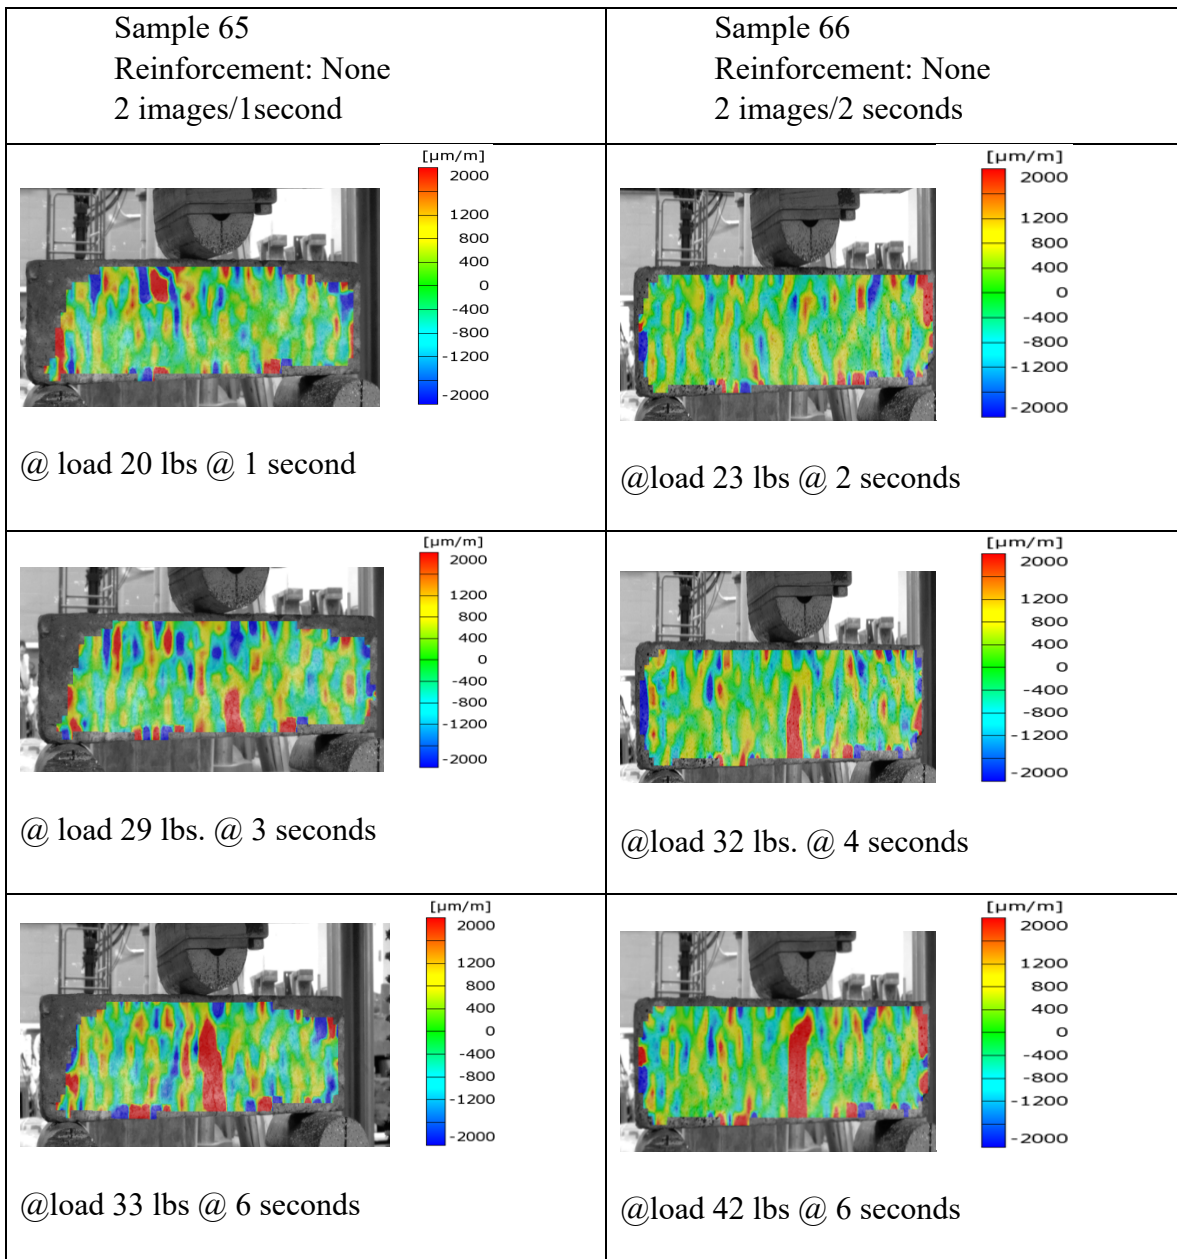
Figure 5.5. Longitudinal strain for specimen 65 and 66

Multiple adobe beams were developed and tested with varying levels of reinforcement in January 2018. The testing followed the same protocols as the July 2017 testing. The applied load along with corresponding load for different specimens with and without reinforcement is shown in Figure below.

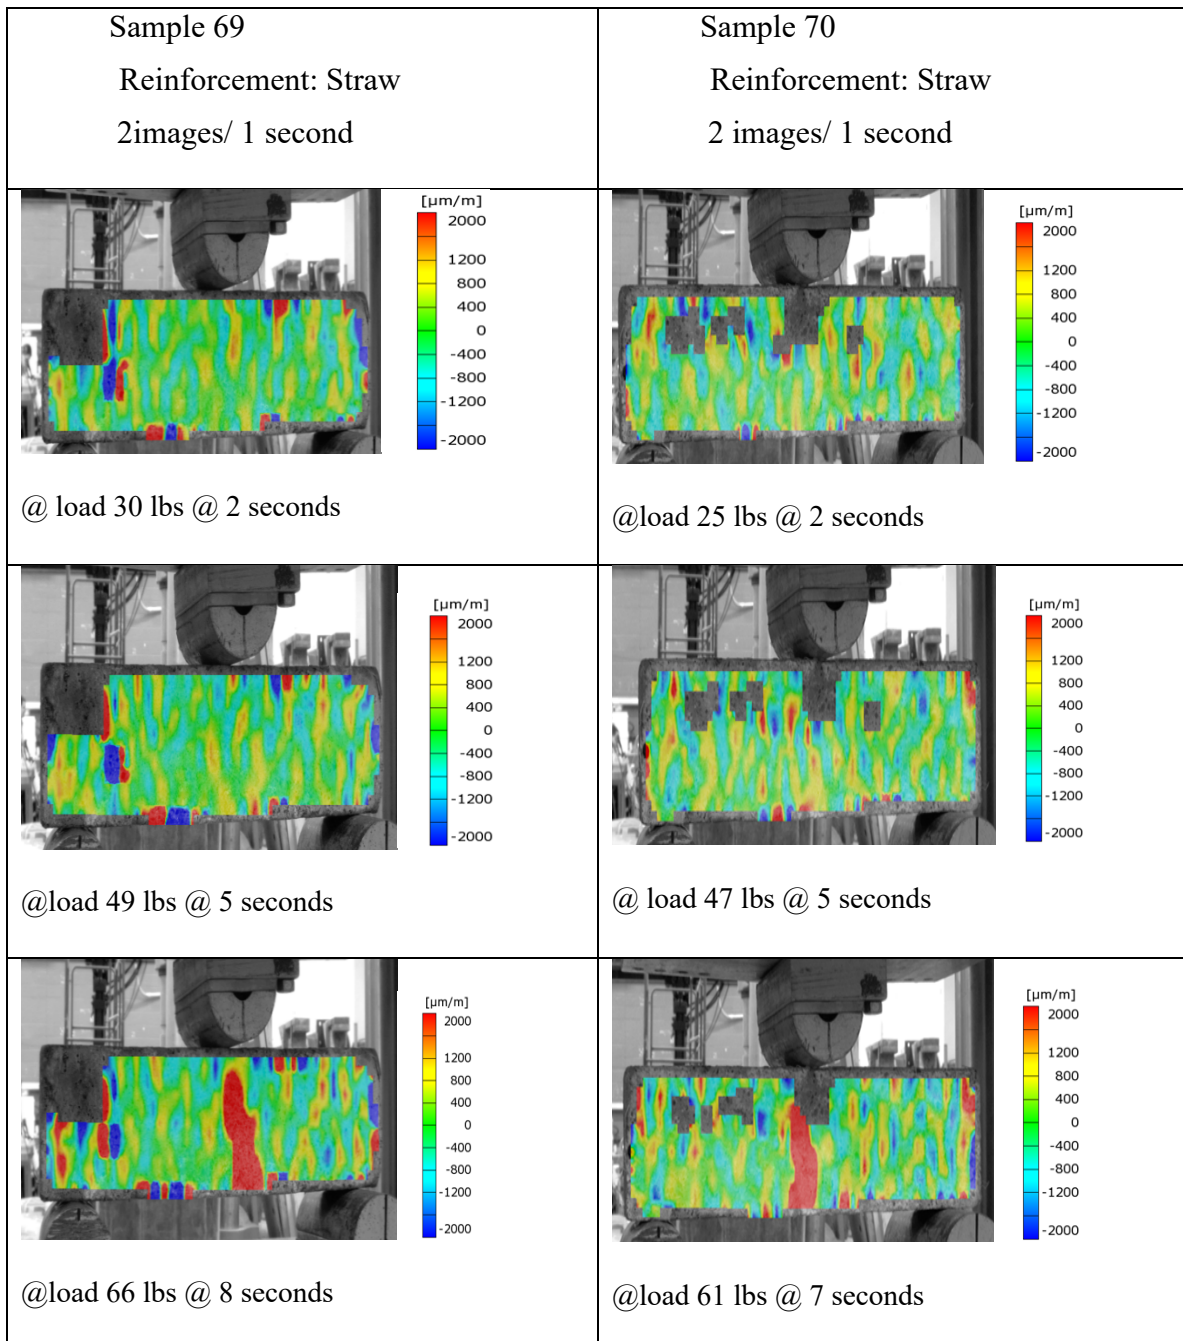
Figure 5.7. Longitudinal strains for specimen 69 and 70

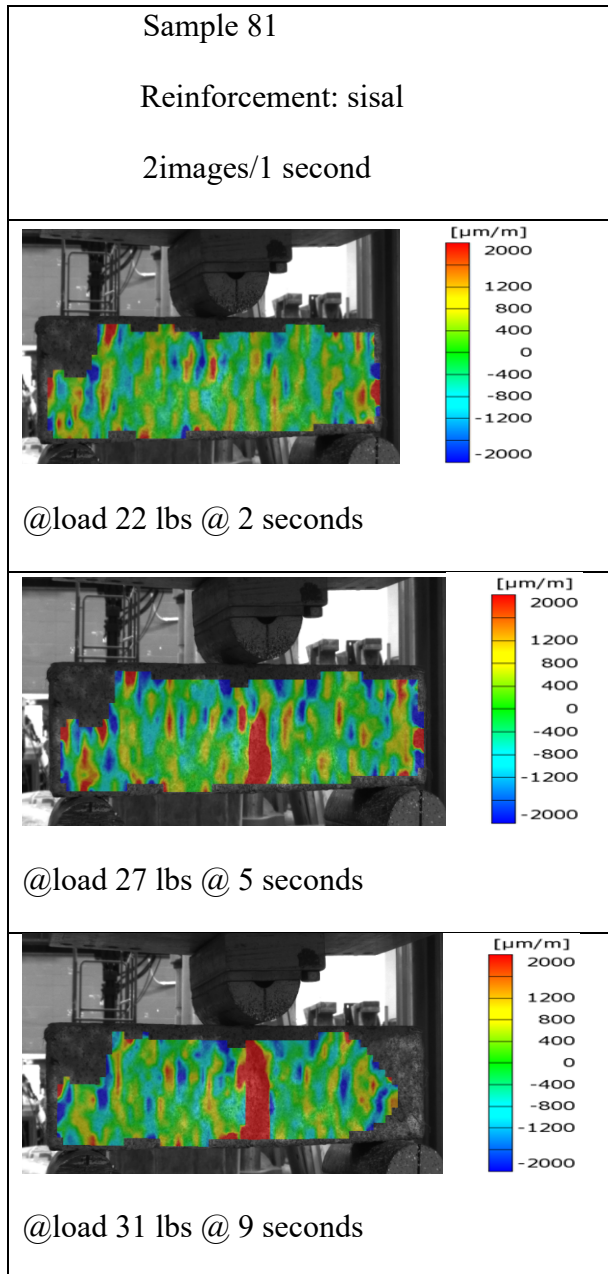
Figure 5.11. Longitudinal strains for sample 81.

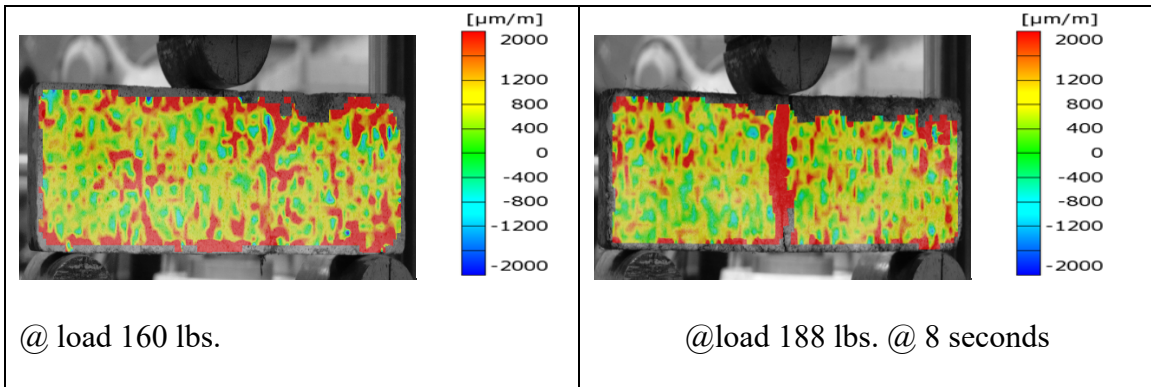
Figure 5.12. Major strain for specimen 202 and 203

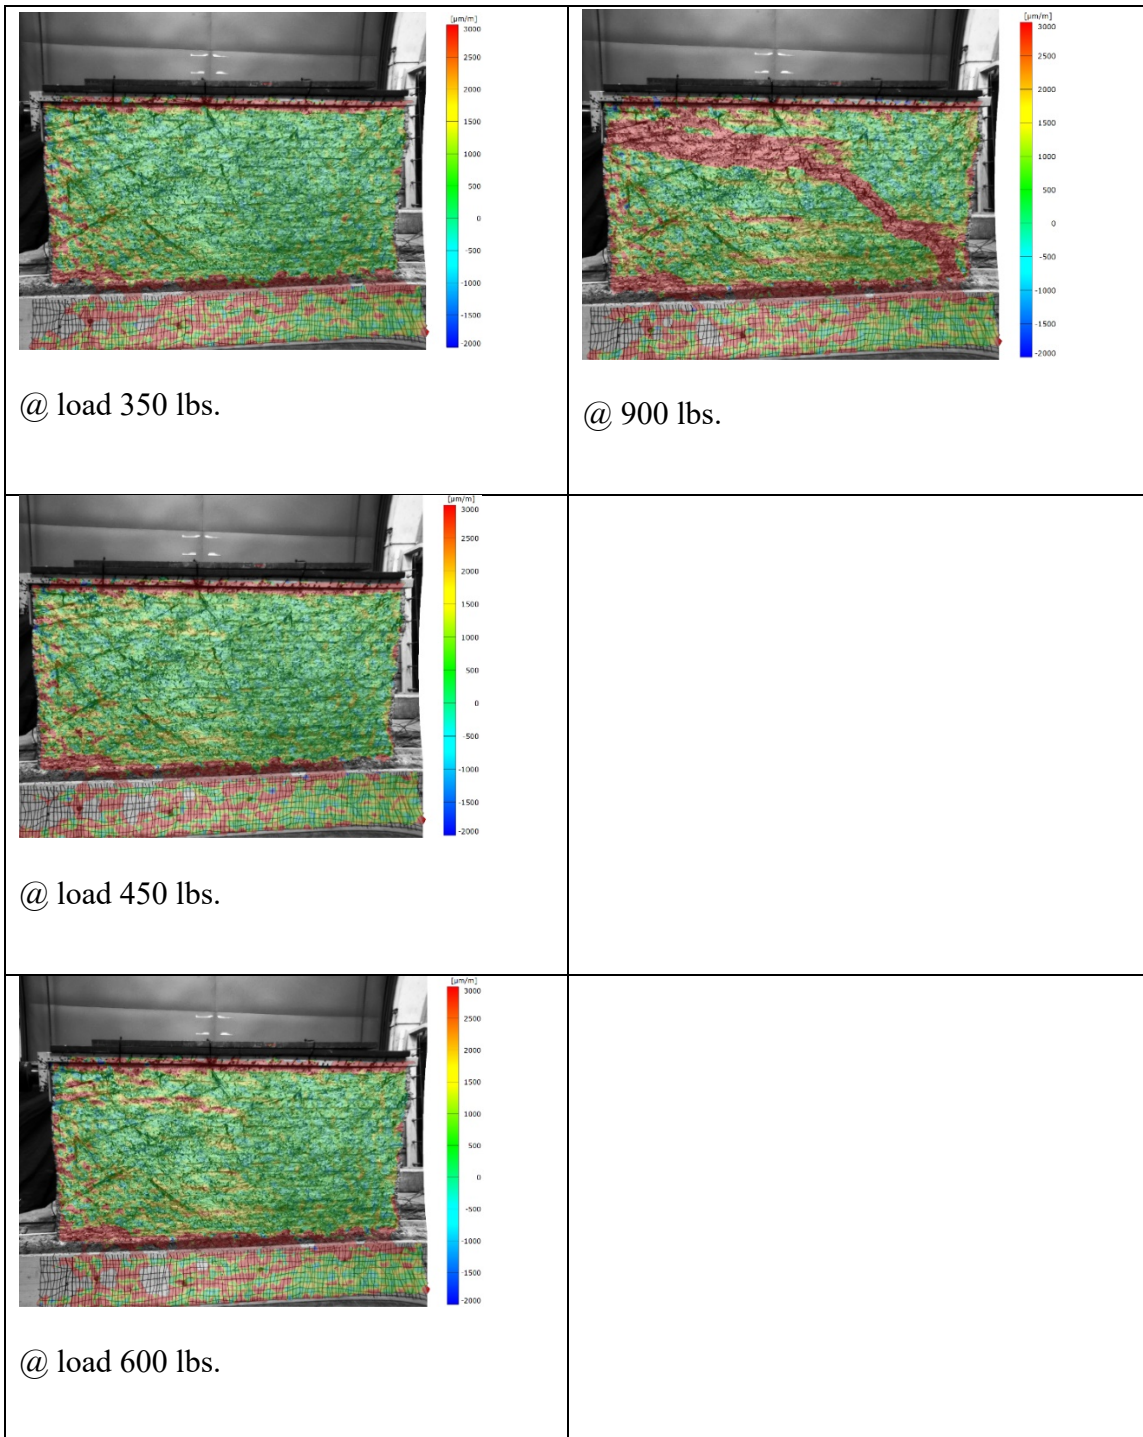
Figure 6.3. Major strain for Wall 6

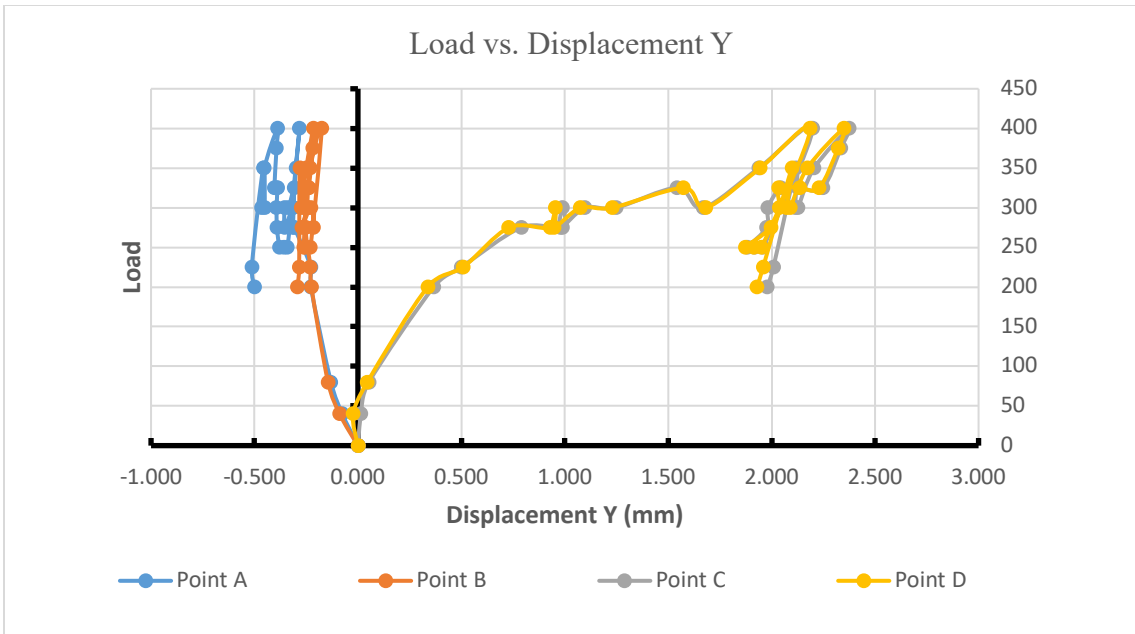
Figure 6.4. Load vs Vertical displacement for four points shown in Figure for Wall

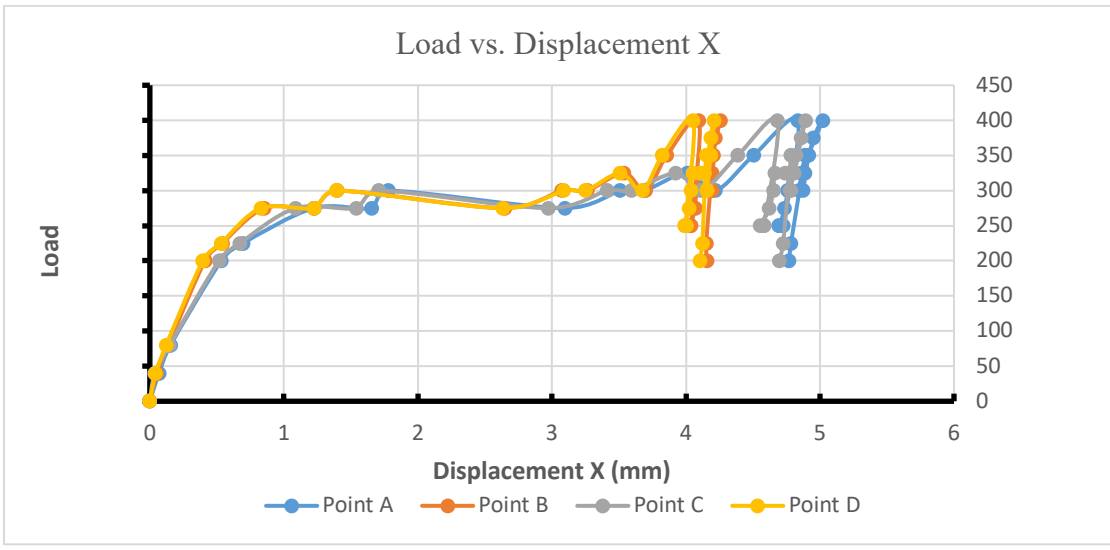
Figure 6.5. Load vs. Horizontal displacement for four points shown in Figure for Wall 7.

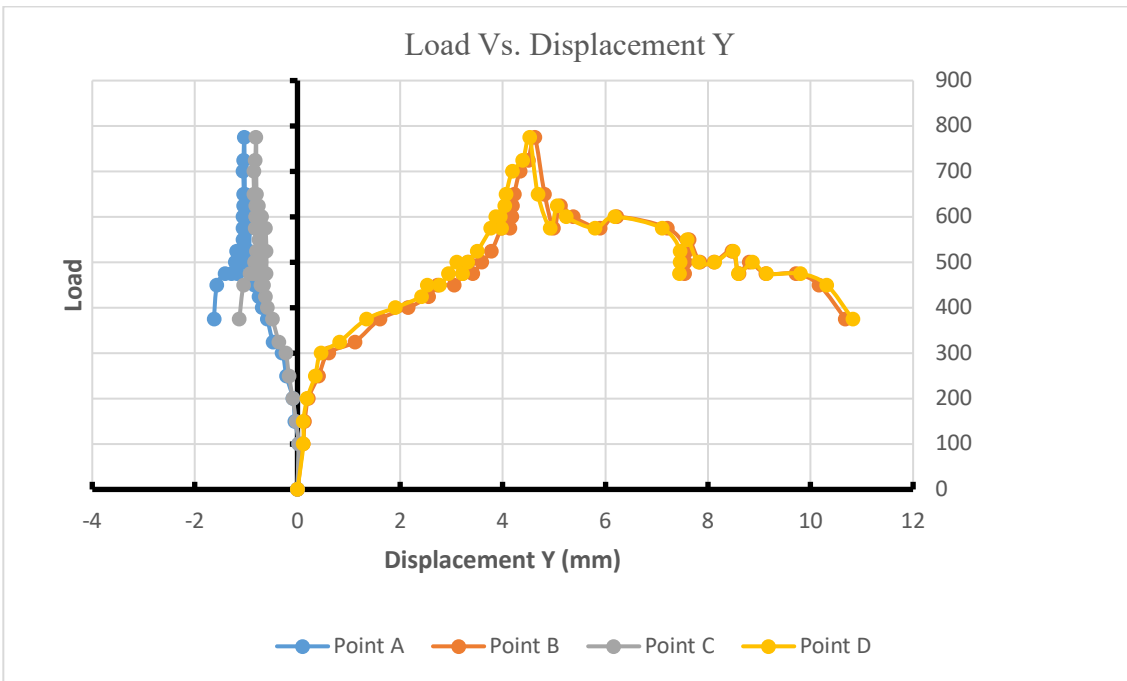
Figure 6.6. Load vs. vertical displacement for four points shown in figure for Wall 8.

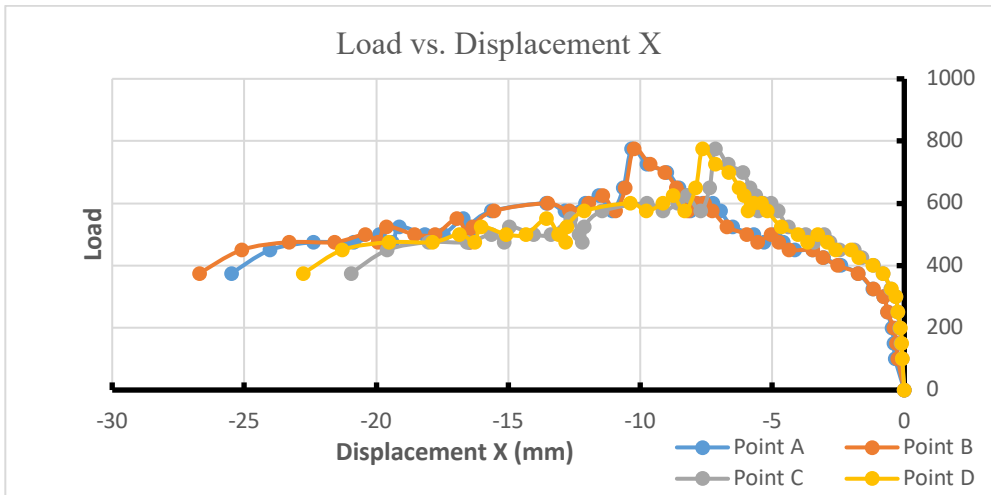
Figure 6.7 Load vs. horizontal displacement for four points shown in figure for Wall 8.

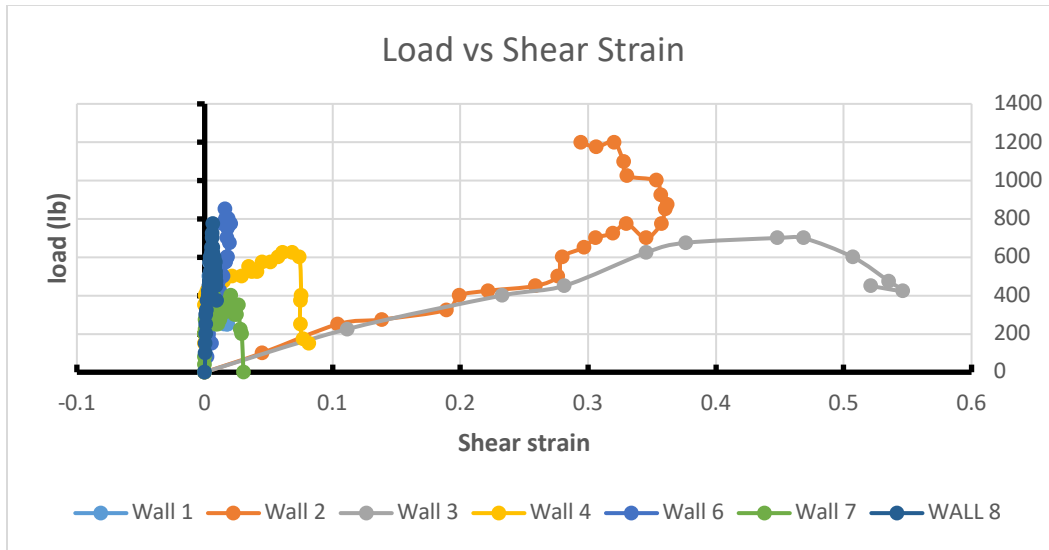
Figure 6.9 Load vs shear strain for all walls

Load vs shear strain curves are plotted for all the wall tested in 2017 and 2018.

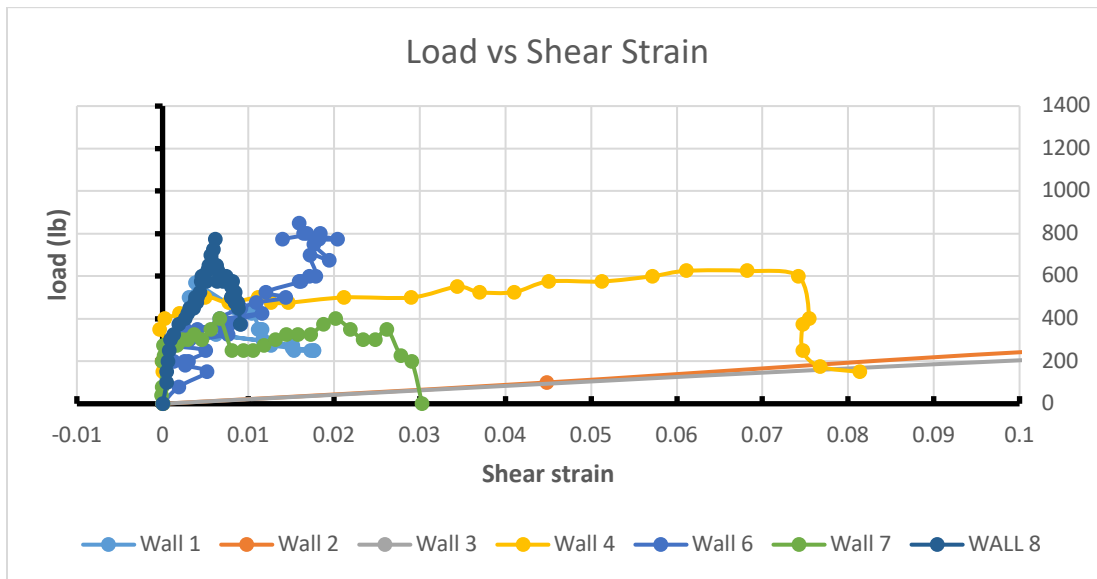
Figure 6.10. Load Vs Shear Strain

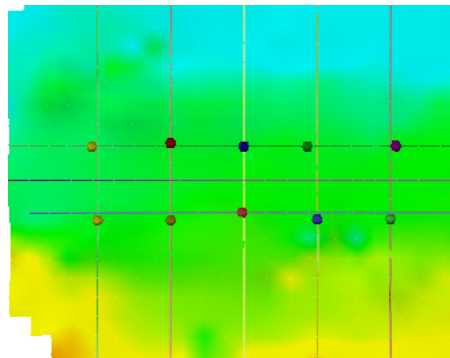
*Figure 7.1. Cube specimens showing top and bottom five points*

Ten points were created in the mid of the specimen as shown in the figure 7.1 such that vertical displacement of each of the points were noted. Horizontal and vertical distance between the points is 25 mm.

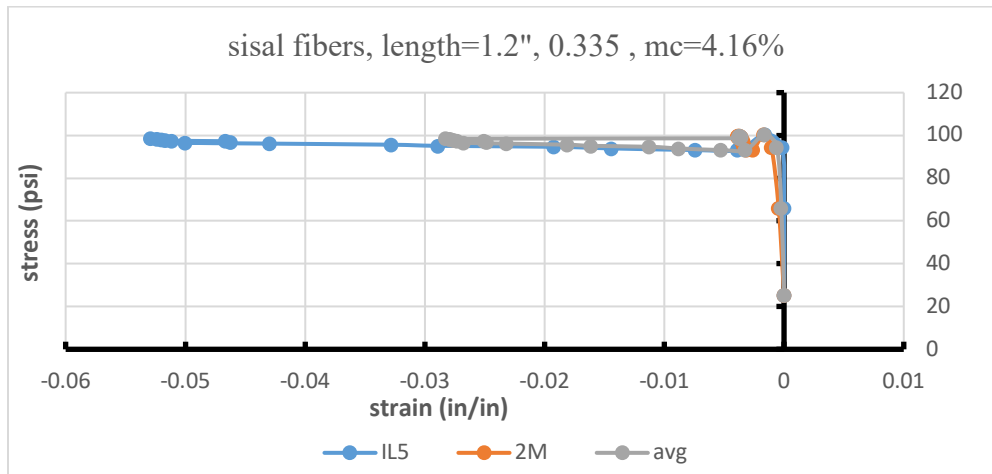
Figure 7.2. Stress vs. stress plots for specimen 1

Stress vs. strain graphs as shown from Figure 7.2 to Figure 7.6 were plotted. For the determination of the modulus of elasticity, average of strain from both the faces of the specimen was calculated and plotted against the respective stress.

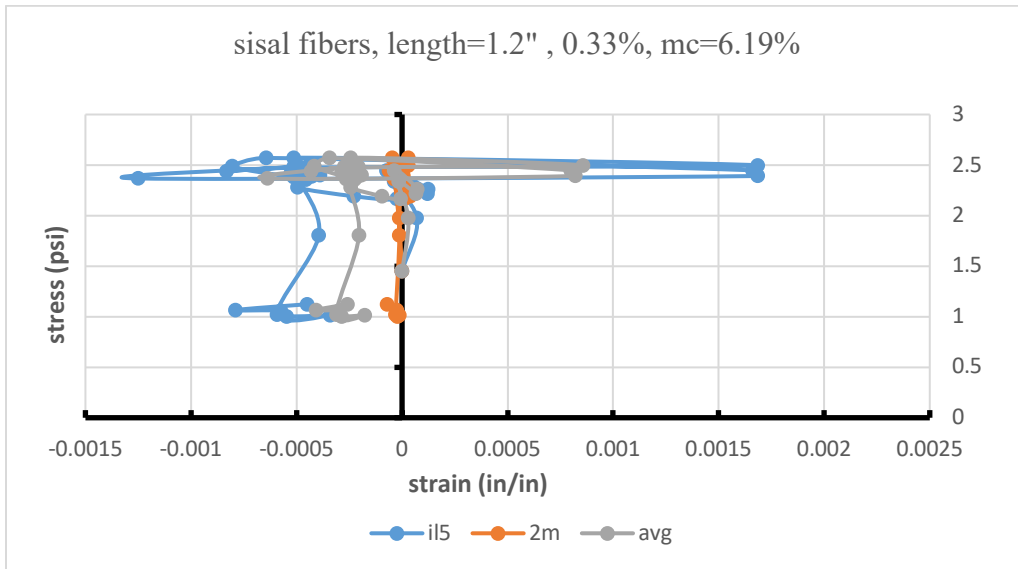
Figure 7.3. Stress vs. stress plots for specimen 2

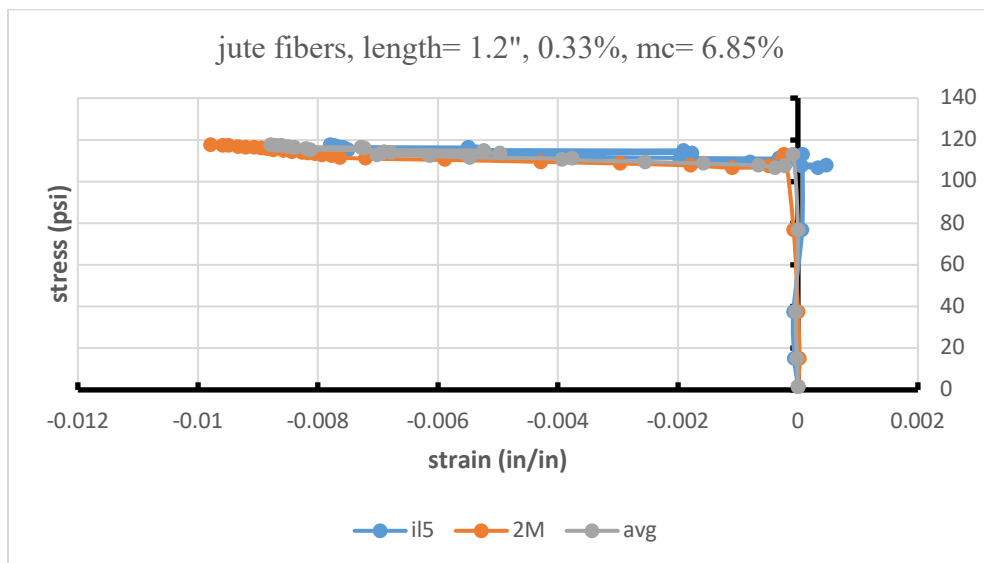
Figure 7.4. Stress vs. stress plots for specimen 3

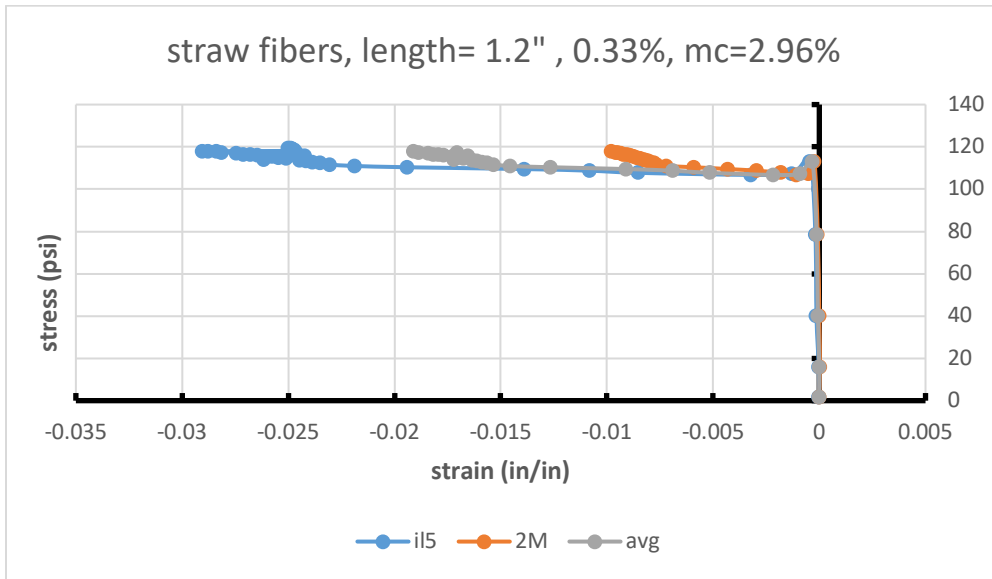
Figure 7.5. Stress vs. stress plots for specimen 4

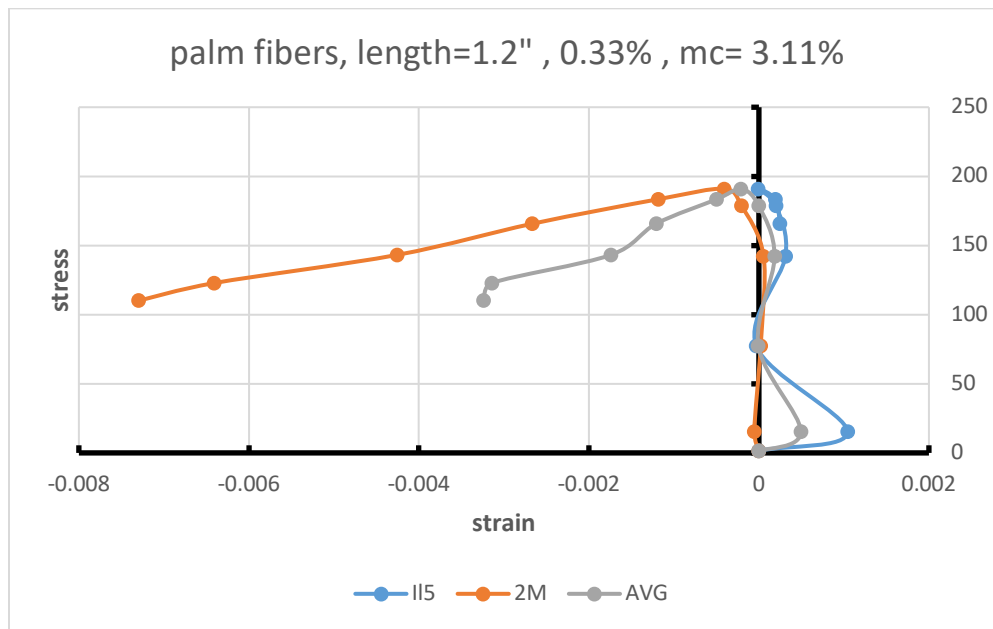
Figure 7.6. Stress vs. stress plots for specimen 5

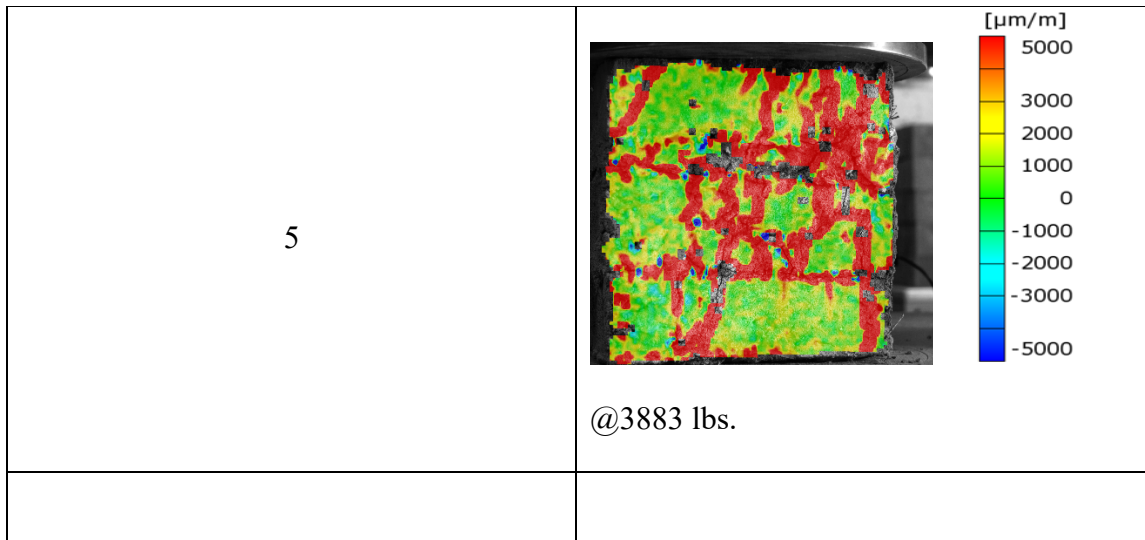
Figure 7.7. Major strains for specimen at particular loads.

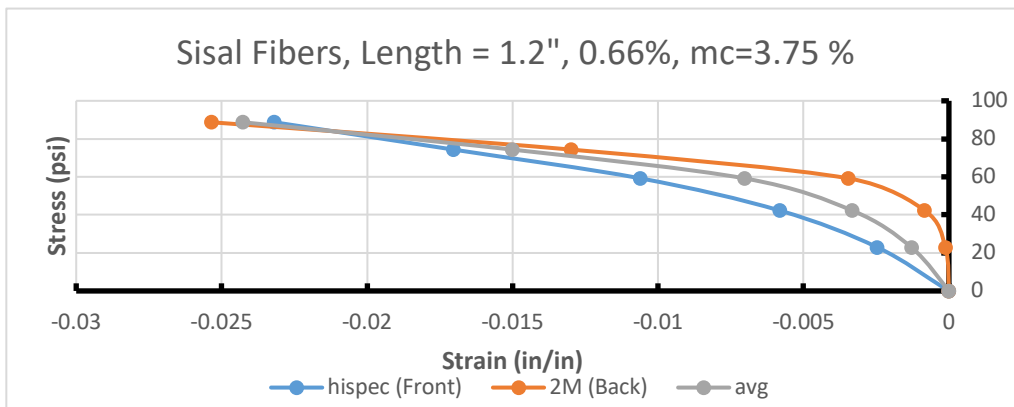
Figure 7.8. Stress vs. stress plots for specimen 6

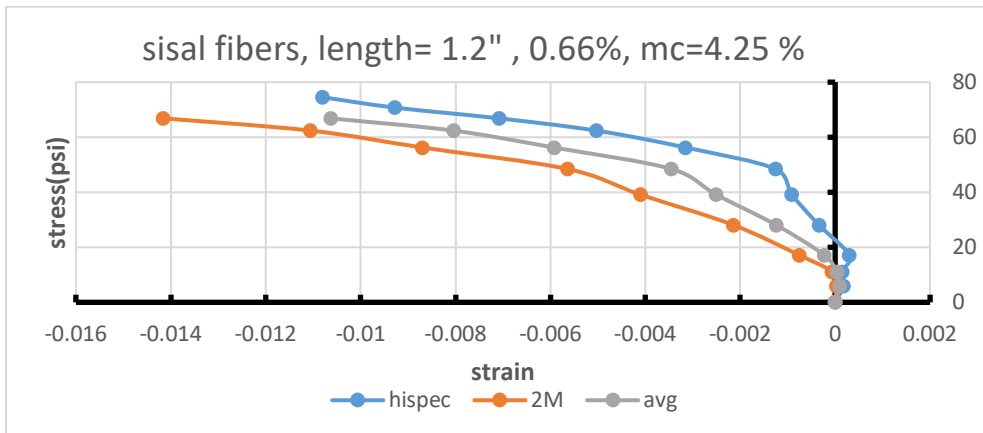
Figure 7.9. Stress vs. stress plots for specimen 7

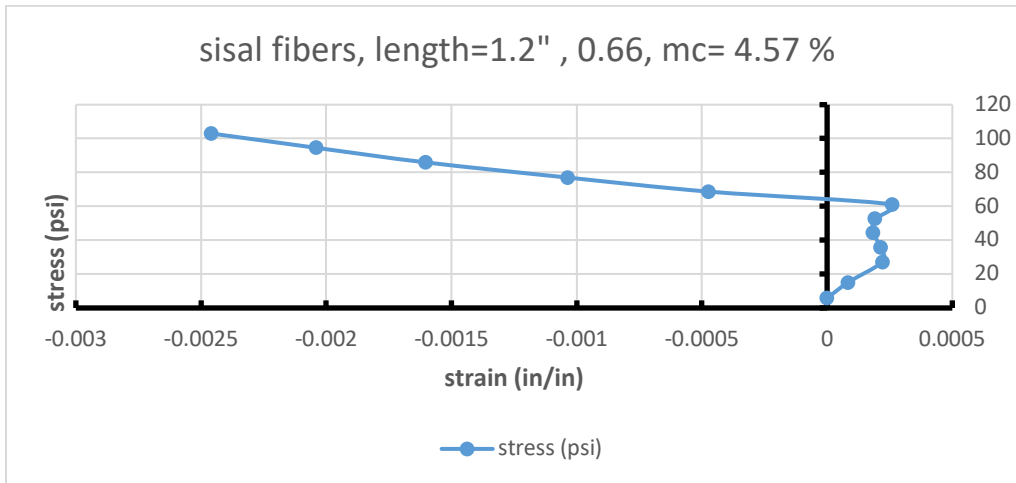
Figure 7.10. Stress vs. stress plots for specimen 8

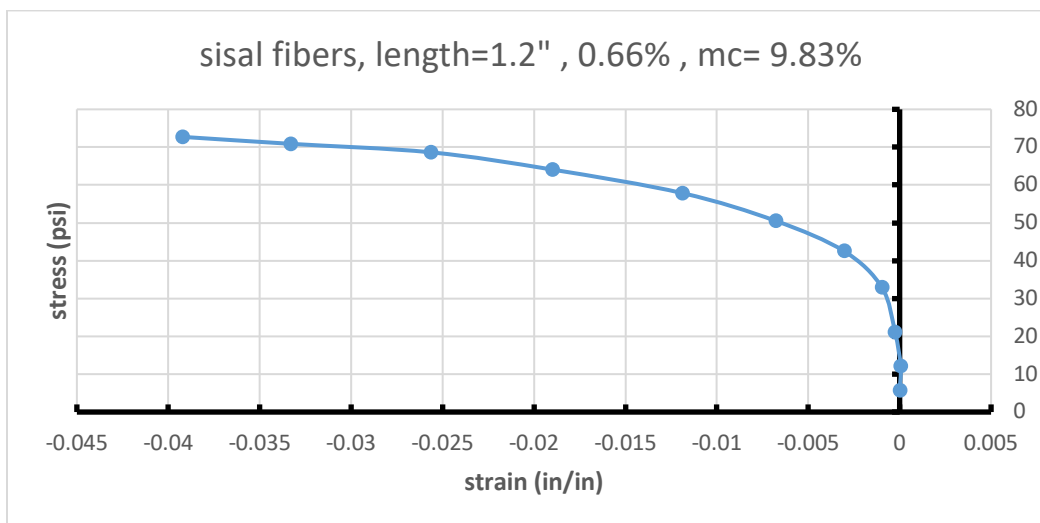
Figure 7.11.: Stress vs. stress plots for specimen 9

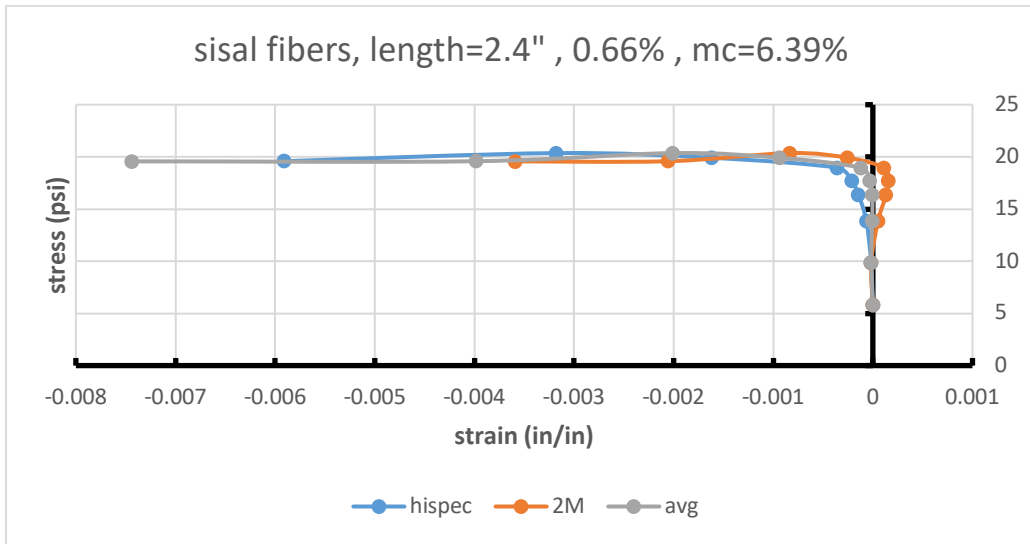
Figure 7.12. Stress vs. stress plots for specimen 10

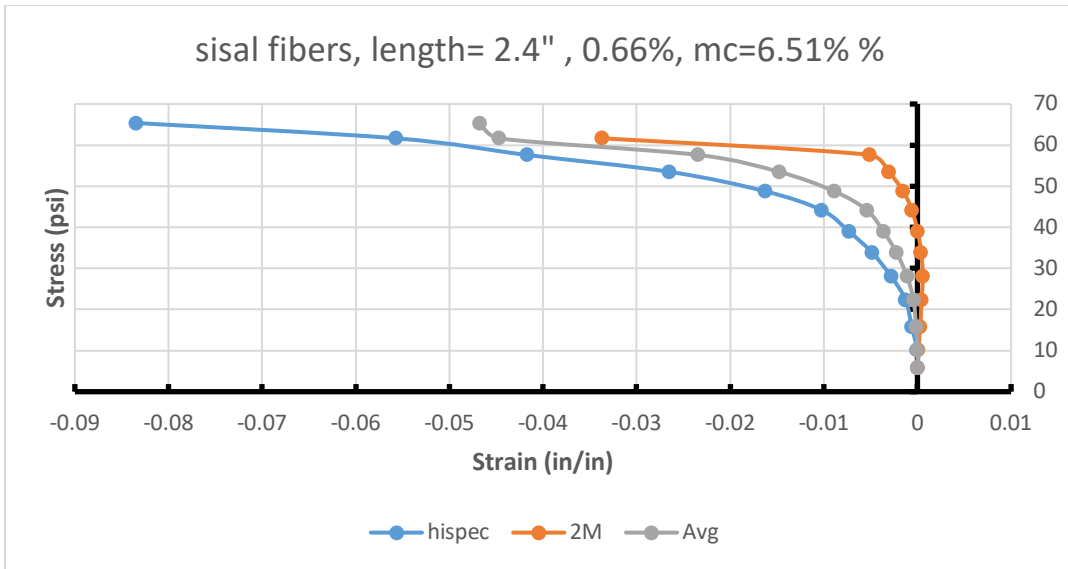
Figure 7.13. Stress vs. stress plots for specimen 11

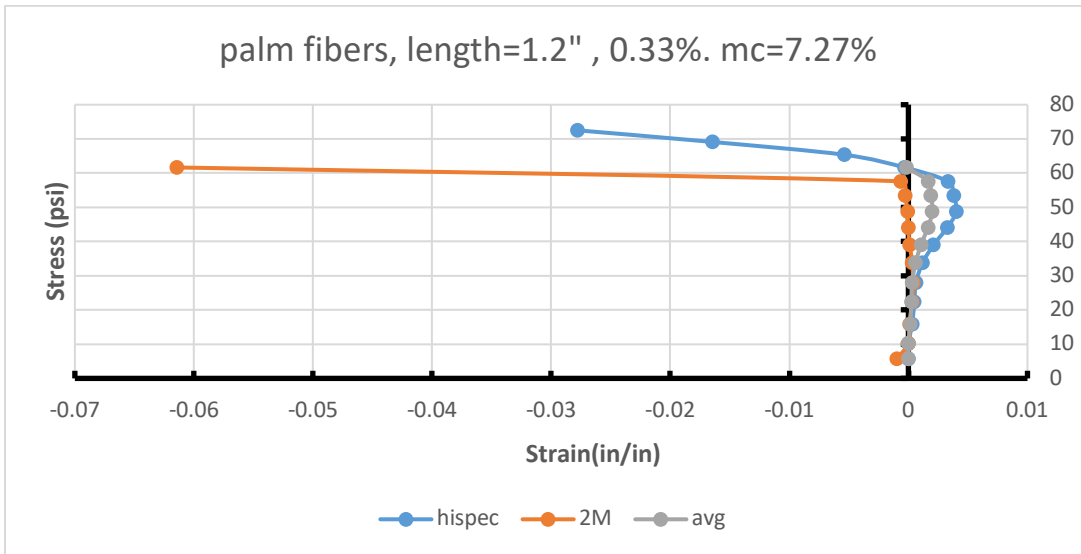
Figure 7.14. Stress vs. stress plots for specimen 12
