## Experimental Investigation of Adobe Structures with Digital Image Correlation

EXPERIMENTAL INVESTIGATION OF ADOBE STRUCTURES WITH  
DIGITAL IMAGE CORRELATION

A thesis submitted in partial fulfillment  
of the requirements for the degree of  
Master of Science in Civil Engineering  
Department of Civil Engineering

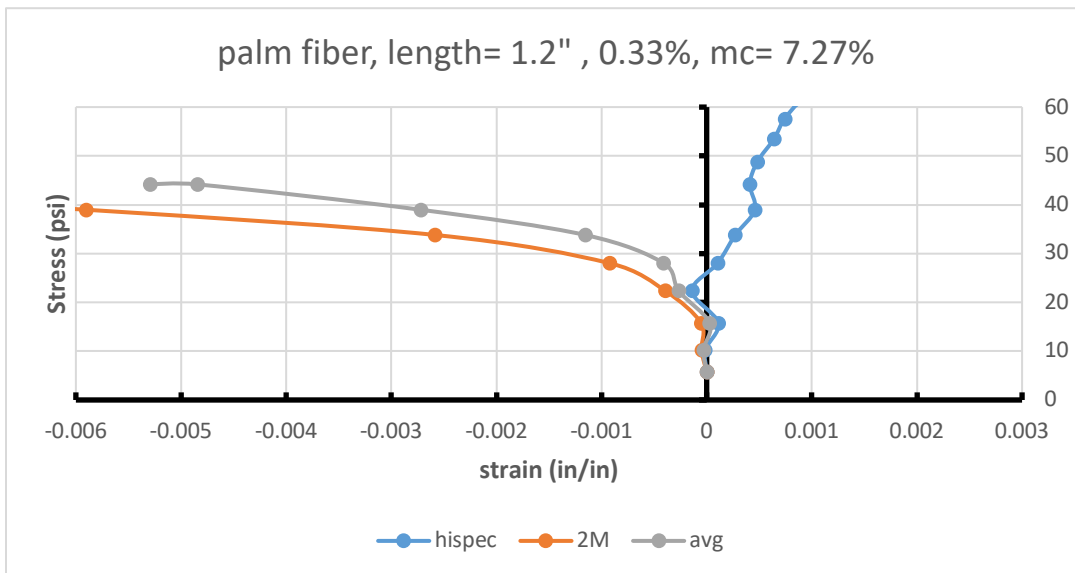
Figure 7.15. Stress vs. stress plots for specimen 13

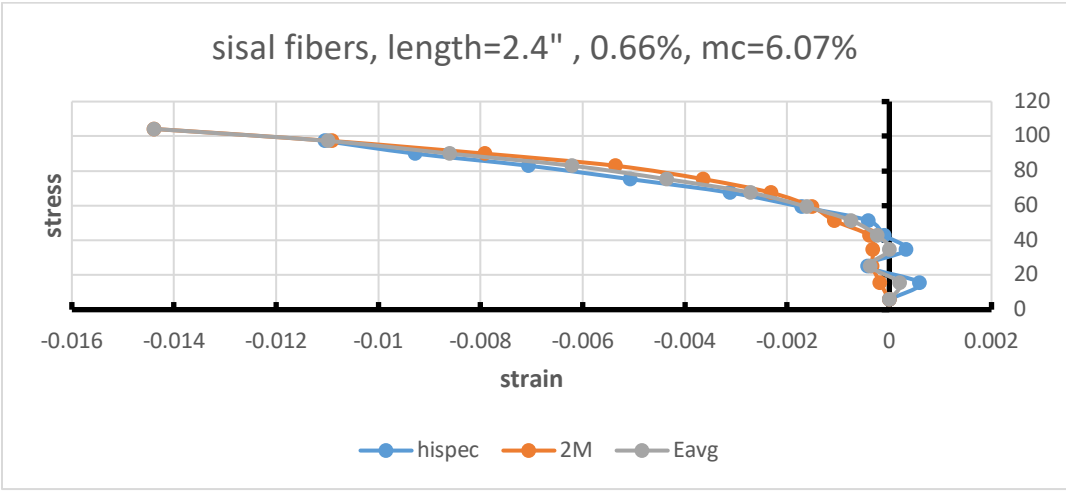
Figure 7.16. Stress vs. stress plots for specimen 14

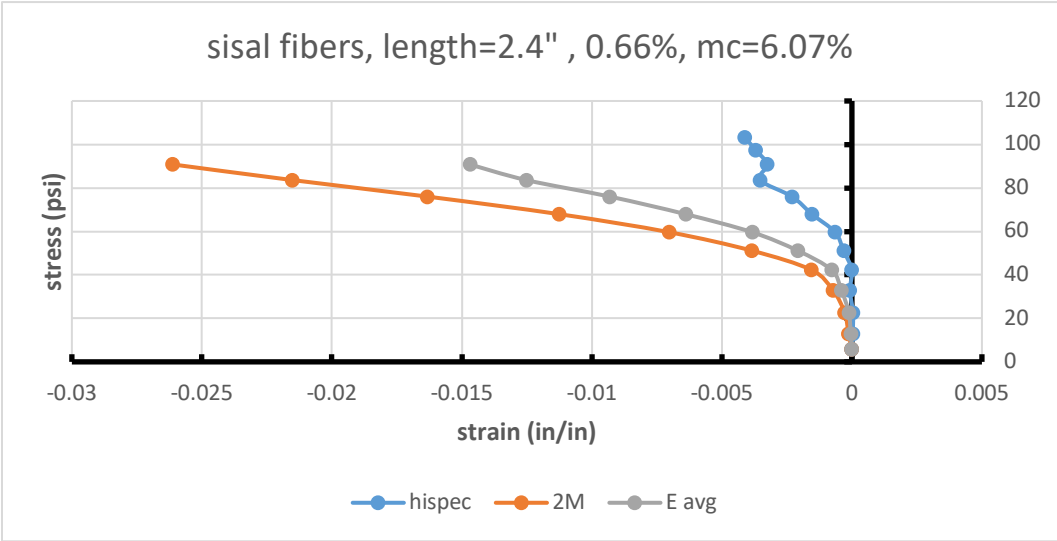
Figure 7.17: Stress vs. stress plots for specimen 15

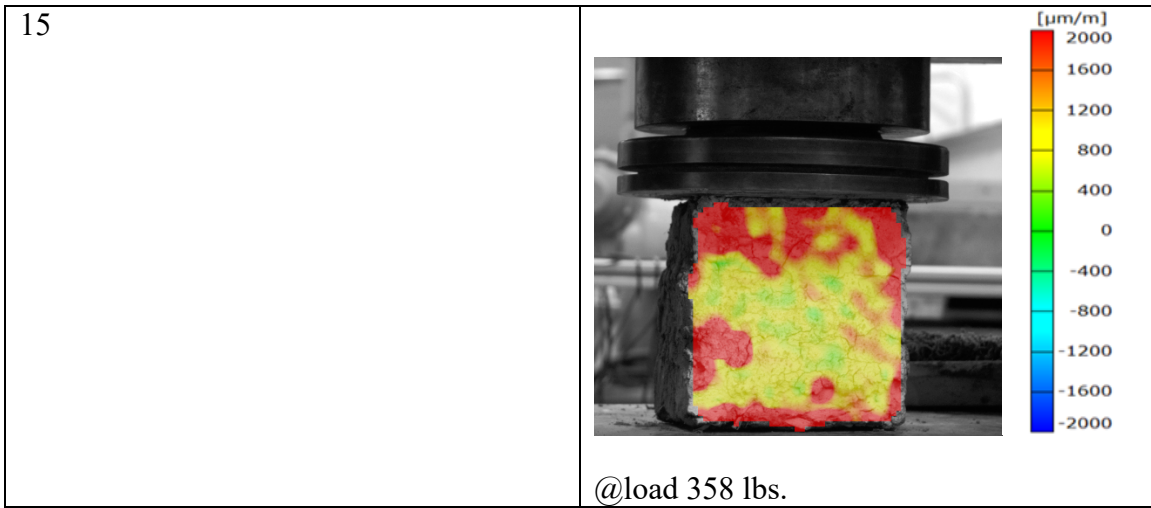
*Figure 7.18. Major strains for specimen at particular given loading condition.*

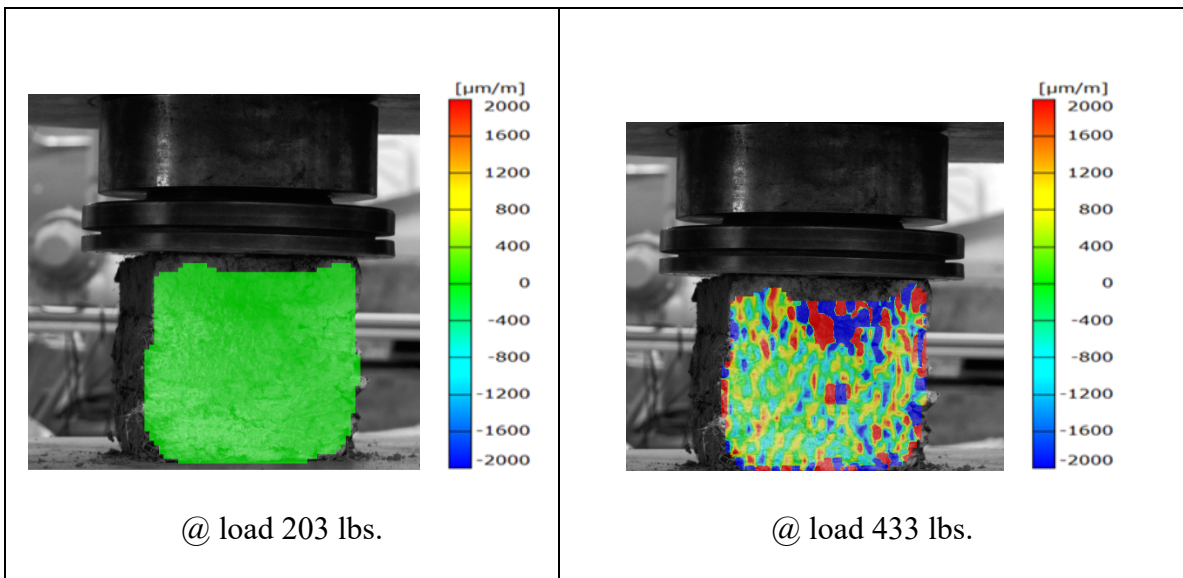
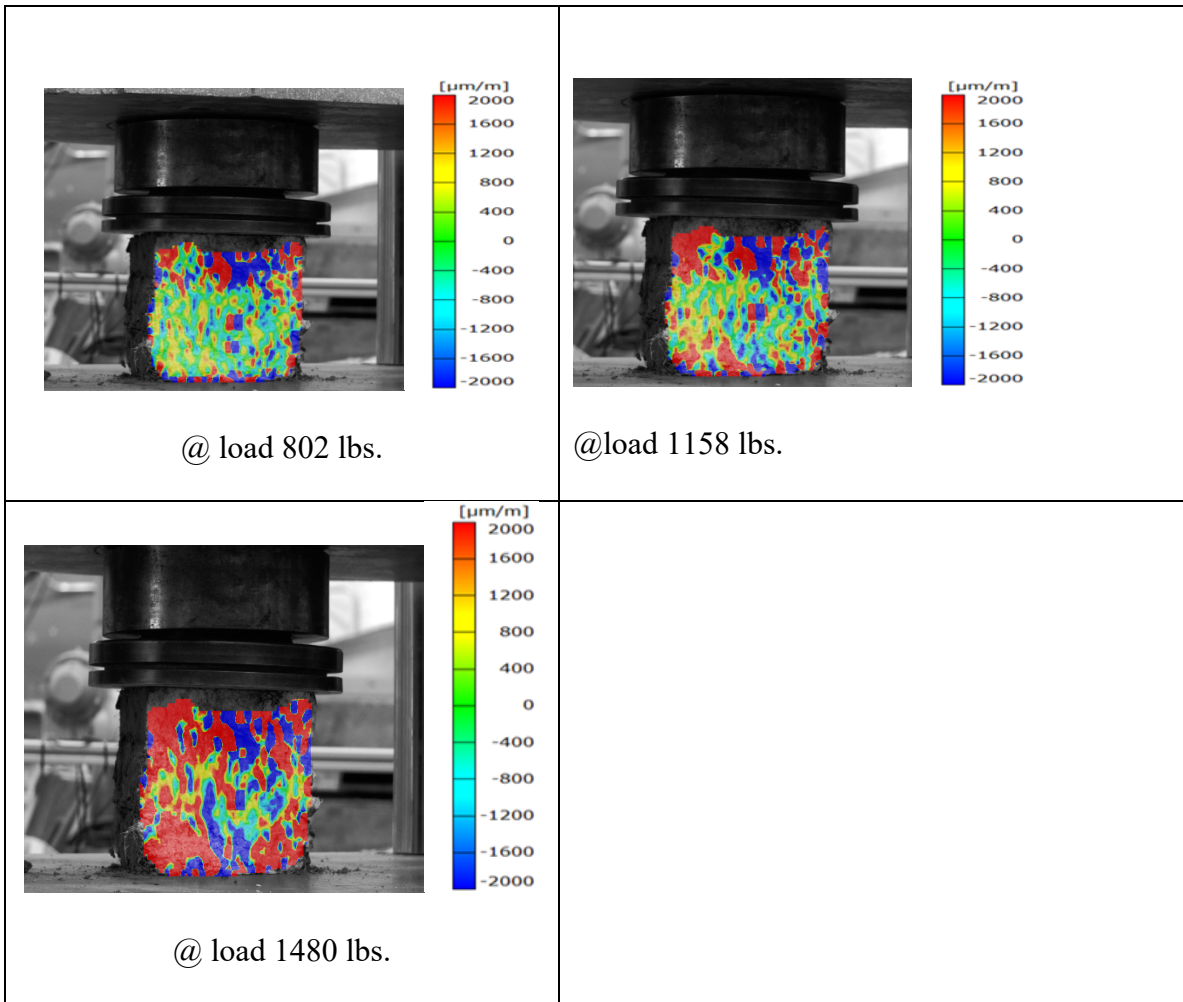
*Figure 7.19. Major strains for different loads for specimen 6.*

Figure 7.17 shows an example of how crack development in specimen can be tracked using ARAMIS.

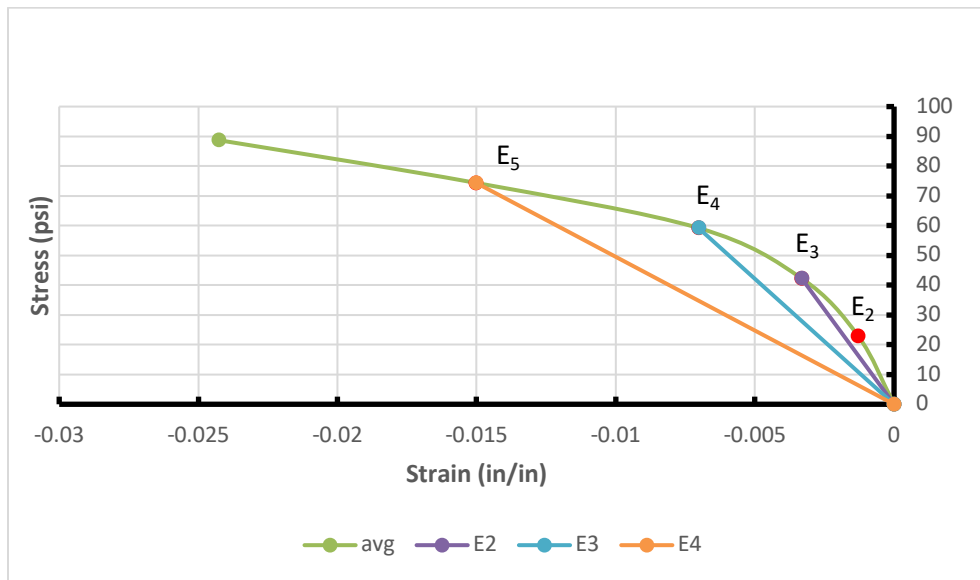
Figure 7.20. Graph showing  $E_2$ ,  $E_3$ ,  $E_4$ ,  $E_5$

Some of the readings included relative movements between the prisms and the machine head. So, the first reading is not considered. The next four readings are considered for determination of Modulus of elasticity which is represented by  $E_2$ ,  $E_3$ ,  $E_4$  and  $E_5$  as shown in Figure 30. The strain values from both the faces are averaged for all the samples except for sample No.8 and sample No. 9 as images of only the front face for these specimens were available.

This approach yields those four values for the modulus of elasticity. The following table (Table 7.3) shows the summary of calculations. Values highlighted in red in the table were eliminated from the overall averages at the bottom because they were positive. Values in pink in the table were eliminated because they were too large (negatively) and do not come close to values available in the literature.
