### Laboratory study on the strength behaviour of two laterally loaded adobe walls

Article

# Laboratory Study on the Strength Behaviour of Two Laterally Loaded Adobe Walls

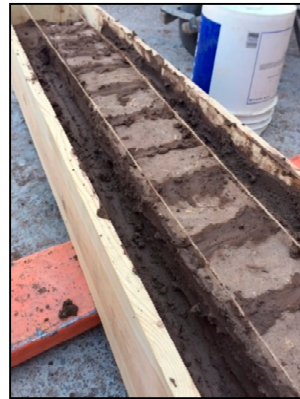
**Figure 1.** Construction of the wall foundation: Adobe bricks being placed in the wooden frame to form the footing.

To represent traditional adobe construction of the southwestern region of the United States of America (USA), two courses of 16 adobe bricks measuring (length × width × thickness) 12.7 cm × 8.9 cm × 2.5 cm were placed in a running bond pattern to form the footing (see Figure 1); the adobe soil mixture without straw was used as the mortar. Mortar joints in the footing measured

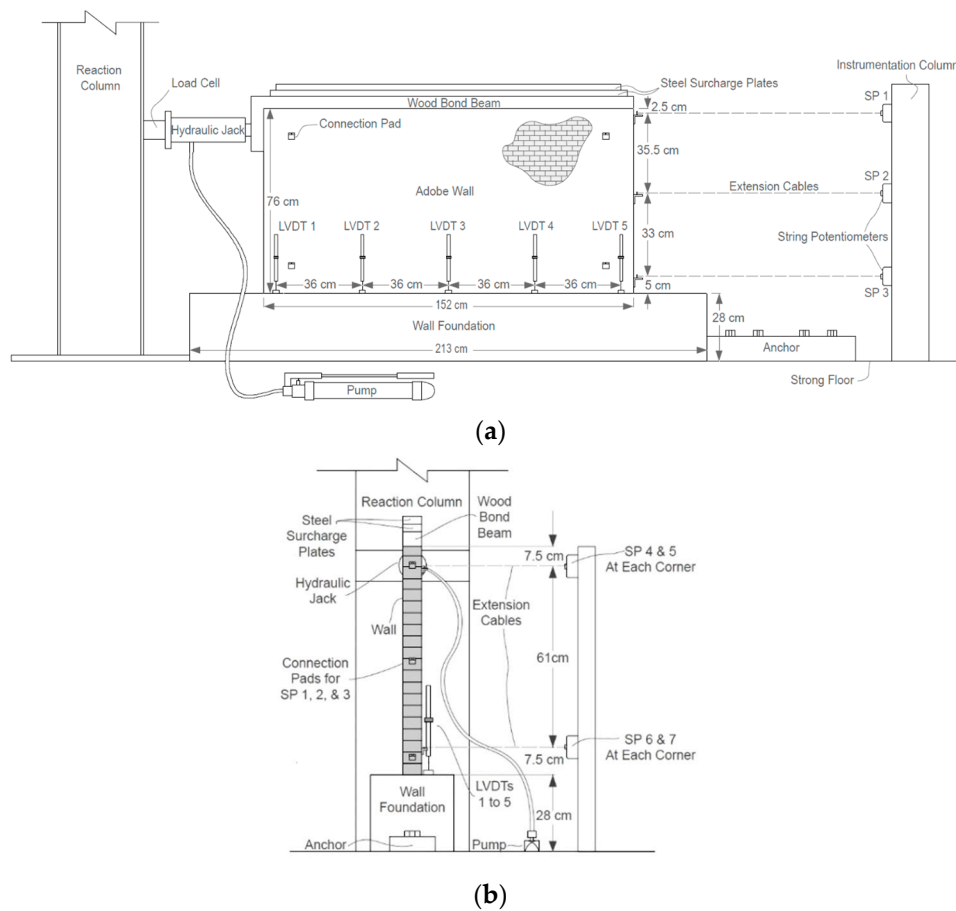
**Figure 2.** Wall test setup and instrumentation: (a) front view, (b) side view.

A bond beam was used to prevent localized crushing failure at the point of application of the lateral load and simulate a roof diaphragm (see Figure 2). For that, six holes (13 cm deep, 2 cm in diameter, spaced at 23 cm) were drilled on the top of the adobe wall and through an L-shaped wood bond beam of the same length as the wall. The L-shaped wood bond beam was positioned on top of the wall and fixed with six steel bars (15 cm long, 0.95 cm in diameter) placed inside the holes. The holes were then filled with a cement mortar with a maximum aggregate size of 2 cm to attach the wooden bond beam to the top of the adobe wall.

The instrumentation consisted of two types of linear displacement transducers, a lateral load inducing hydraulic jack and pump combination, a load cell, a data acquisition system, and a test monitoring and data processing program. The instrumentation layout can be seen in Figure 2. A single-direction hydraulic jack with 15.2 cm stroke and 300 kN capacity was used. A small, manually operated hydraulic pump was used to drive the piston at an approximately constant rate. The load cell was placed between the reaction column and the hydraulic jack. The wall deformations and displacements in the in-plane and out-of-plane directions were measured with seven string potentiometers (SP), also known as cable-extension transducers. Displacements along the vertical axis of the walls were measured with linear variable displacement transducers (LVDTs). The data from the instrumentation was recorded with a National Instruments data acquisition unit.

The test setup shown in Figures 2 and 3 includes various measurement instruments, a reaction column, the adobe wall and foundation wood frame, the wood bond beam and steel surcharge plates, the connection and resting pads for sensor placement, and an instrumentation column. The L-shaped wood bond beam was used to transfer and distribute the lateral load from the hydraulic jack to the wall. Two steel plates (12.7 cm wide, 2.5 cm thick) were attached to the bond beam to represent a distributed roof load of 0.44 kN/m for the quarter-scale wall model. The tests were stopped when the wall resistance to lateral loading decreased significantly (i.e., failure).

For Wall 1, LVDT 1 and LVDT 5 were attached to the front face of the wall at 2.5 cm from the wall edges, and LVDT 3 was attached to the centre of the wall face (see Figure 2a). LVDT 2 and LVDT 4 were attached in between LVDT 1 and LVDT 3, and LVDT 3 and LVDT 5, respectively. For Wall 2, LVDT 1 and LVDT 4 were attached to the front face of the wall at 2.5 cm from the wall edges; LVDT 2 and LVDT 3 were attached evenly spaced between LVDT 1 and LVDT 4. One of the LVDT sensors was damaged during the testing of Wall 1, and a replacement was not available for testing Wall 2; however, the loss of this instrumentation did not compromise the results of the test.

The LVDTs were secured to the wall with wooden connection pads epoxied to the adobe bricks. Three string potentiometers, measuring in-plane wall displacements, were secured to the instrumentation column about 91 cm from the edge of the wall; string potentiometer SP1 was placed 2.5 cm from the top of the wall; string potentiometer SP3 was placed 5 cm from the bottom of the wall; and string potentiometer SP2 was placed at mid-height of the wall. Extension cables were used to connect these devices to the wall. Four additional string potentiometers (SP4, SP5, SP6, and SP7) to measure the out-of-plane displacements were attached to a similar instrumentation column parallel to the wall and footing (along the wall horizontal axis), each one installed 7.5 cm from the wall edge at top and bottom of the wall, as shown in Figure 2b.

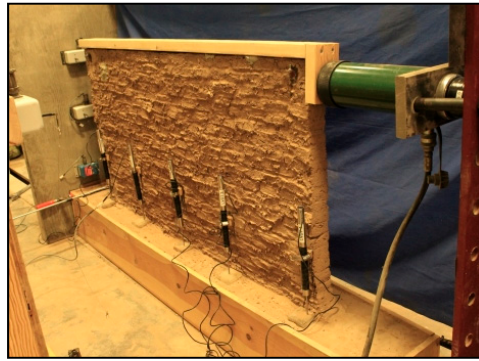
**Figure 3.** Wall model (Wall 1) with instrumentation and loading components.

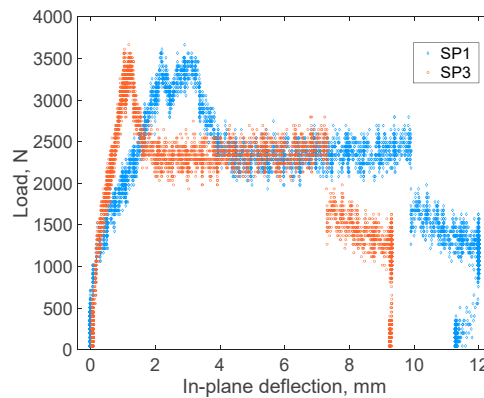
Figure 4. In-plane displacements of Wall 1.

The average water contents at the top, middle and bottom areas of Wall 1 were 4.06%, 4.44% and 3.86%, respectively, and in the footing and foundation soil was 4.63%. In-plane deflections measured by SP1 and SP3 during loading are shown in Figure 4. The maximum deflections of SP1 and SP3 were 12.0 mm and 9.3 mm, respectively. Initially, SP1 had a higher deflection than SP3 indicating that the

wall was rocking. At a lateral load of approximately 3600 N, Wall 1 cracked and lost strength and stiffness. As loading continued, both SP1 and SP3 increased, indicating that the wall was rocking as well as sliding along the crack. Out-of-plane deflections were captured during the test by SP4, which measured a maximum displacement of 11 mm, as shown in Figure 5. This indicates that Wall 1 was also tilting or twisting out-of-plane.

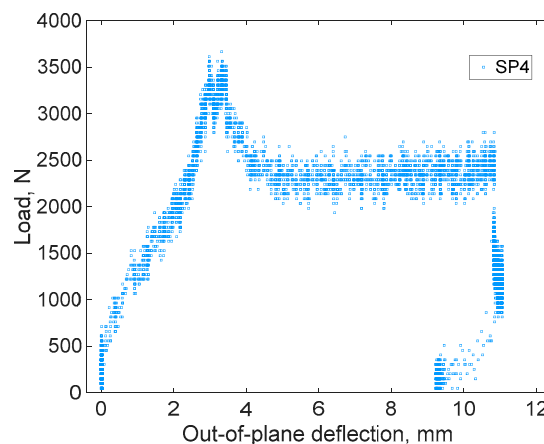
Figure 5. Out-of-plane displacement of Wall 1.

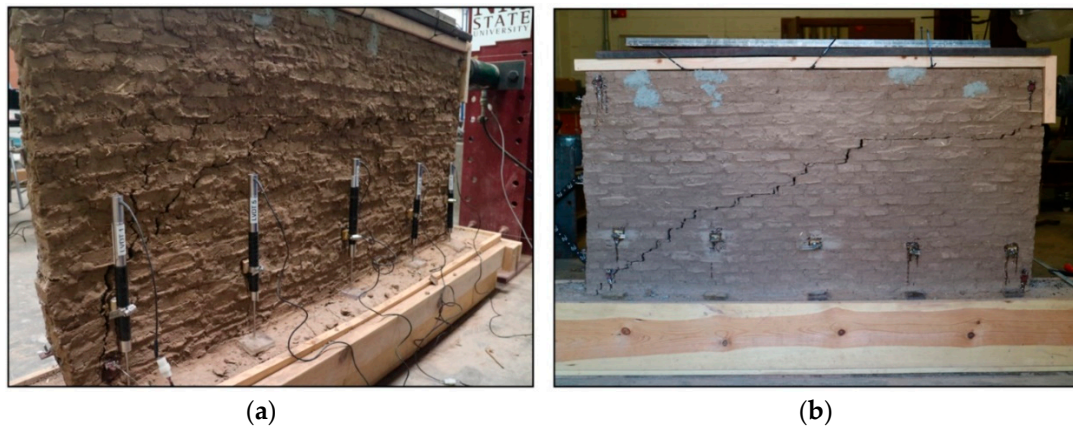
Figure 6. Wall 1: (a) During loading; (b) after failure (after test completion).

Wall 1 withstood a maximum load of about 3600 N (Table 1) with minor deflections in-plane and out-of-plane at that load. At maximum load, SP1, SP3, and SP4 measured deflections of about 3.0 mm, 1.0 mm, and 3.0 mm, respectively. After reaching a load of 3600 N, Wall 1 lost approximately 38% of its capacity and the load dropped to about 2220 N due to cracking. As the test continued, the load slightly increased again due to friction resistance developed along the sliding plane resulting from the rough nature of the sliding surfaces. Eventually, Wall 1 failed completely at 2560 N as the crack along the mortar bonds continued to propagate and separate (see Figure 6).

Wall 2 experienced cracking along the location between dry and wet regions at an early load, but ultimately the failure was similar to that observed in Wall 1 (Figure 9). Wall 1 had a peak load and then dropped suddenly after a crack formed diagonally across the wall length (Figure 6), following the joints between the adobe bricks. After peak load, Wall 1 continued to carry the load, but crack propagation eventually led to ultimate failure. Wall 2 followed a similar trend but there was not a sharp drop of the load. However, the in-plane (lateral) load carrying capacity was approximately 75% of that of Wall 1, indicating that higher water content in the bottom part had a significant effect on the wall strength. Additionally, Wall 2 had considerably more out-of-plane twisting and sliding along the transition zone between the wet and dry regions of the wall.

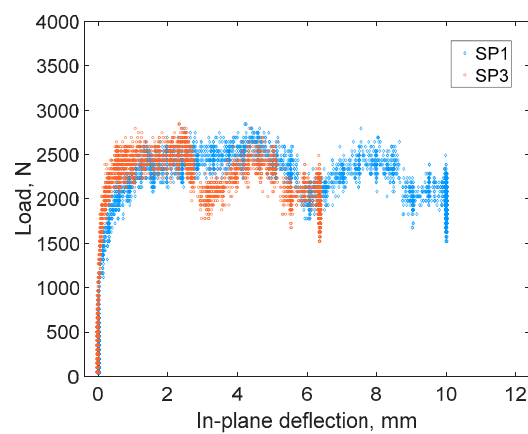
Figure 7. In-plane displacements of Wall 2.

The average water contents at the top, middle and bottom areas of Wall 2 were 3.38%, 3.30% and 7.25%, respectively, and in the footing and foundation soil was 8.06%. In-plane deflections measured by string potentiometers during loading are shown in Figure 7. The maximum deflections of SP1 and SP3 were 10.0 mm and 6.4 mm, respectively. The wall displacements indicated that Wall 2 rocked as well as slid in the in-plane direction. Deflection measurements indicated that Wall 2 also moved out-of-plane, twisting and tilting as the load was applied. The maximum deflection measured by SP4 was 8.8 mm, as shown in Figure 8.

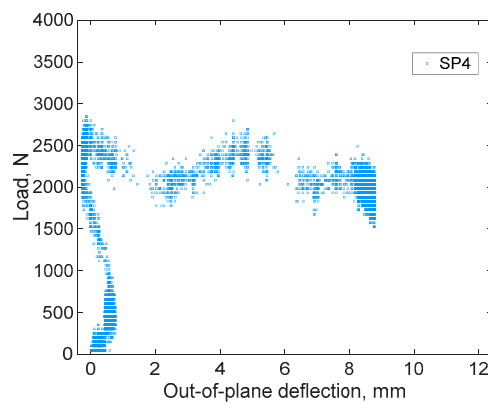
Figure 8. Out-of-plane displacement of Wall 2.

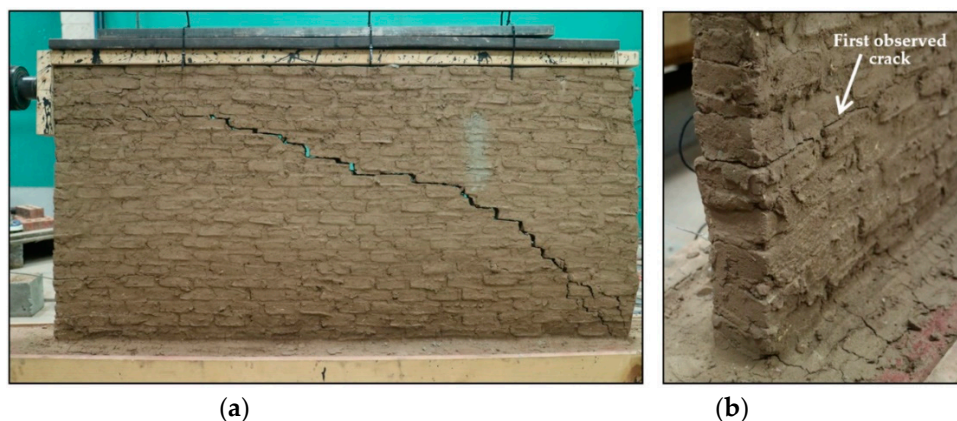
**Figure 9.** Wall 2: (a) near failure; (b) first crack at the transition between wet and dry regions.

Wall 2 withstood a maximum load of approximately 2670 N (Table 1) with relatively small in-plane and out-of-plane deflections at that load. At maximum load, SP1 and SP3 measured deflections of about 2.4 mm, and SP4 did not measure a deflection due to the twisting effect. After reaching the maximum load of 2670 N, Wall 2 lost about 25% of its capacity dropping to about 2000 N (see Figures 7 and 8) due to cracking (see Figure 9a). Even though the wall seemed to regain some capacity, to approximately 2450 N, it eventually failed again, and the test was stopped because the out-of-plane deflection became excessive. The first crack was observed at a load of 1110 N at the transition zone between the wet and dry regions of the wall (see Figure 9b). Even though the first crack appeared in that zone, the crack that made the wall fail was a shear crack through the dry section of the wall (see Figure 9a).
